A+ HOME INSPECTIONS

HOME INSPECTION REPORT

Evaluation of property located at: **123 Easy Street, Nashville, TN**
Inspection is performed for: **Mr. and Mrs. Buyer**
Time of the inspection is: **February 26, 2010 9:30 AM to 12:40 PM**

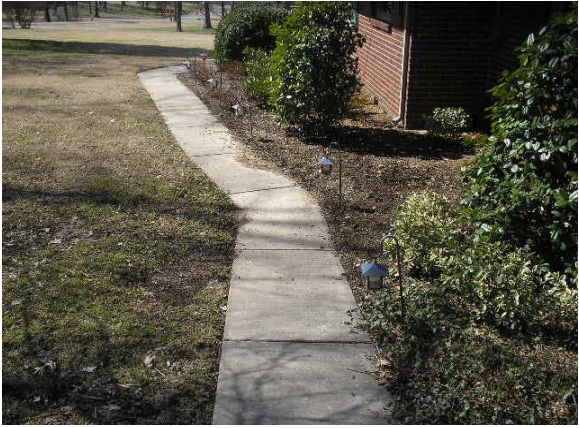
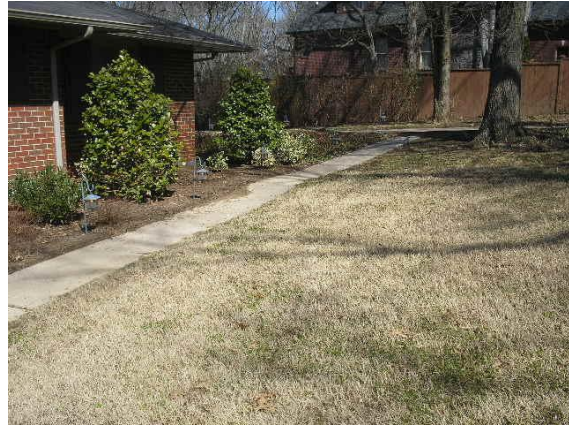
1. This home is built on a lot, which slopes from front right to rear left. So, water runs down toward the front right and right end of the house.
2. Mud has washed onto the front sidewalk.

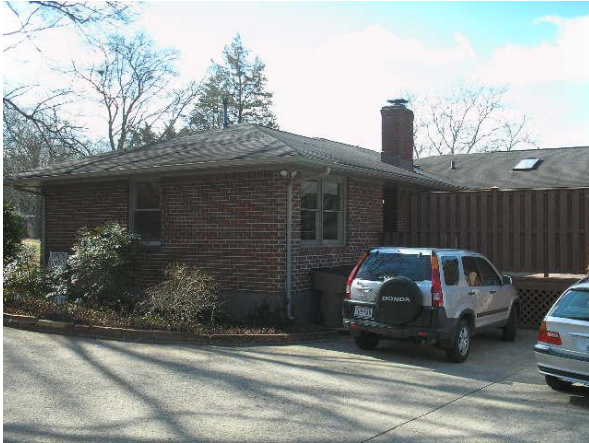
3.
4. Ground is actually sloping toward the house in places, like on right end of house.

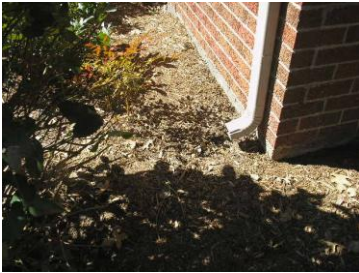
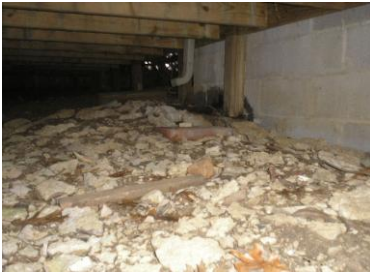
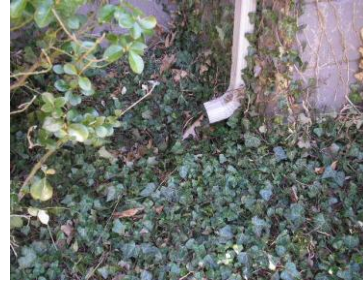
1. Add downspout extensions. There are no downspout extensions or splash blocks on several downspouts; like on the front corners, under deck,

- 2.
3. Add downspout extensions where the downspouts dump out under the deck.
4. I recommend adding solid downspout extension pipes on downspouts to direct the roof water away from the foundation. Secure extensions to downspouts with non-corrosive screws.
5. Bury the downspout extensions and cover their drain ends with screens or pop-up drains.

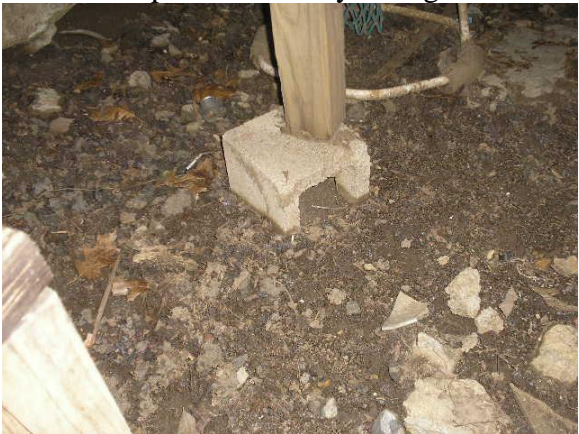
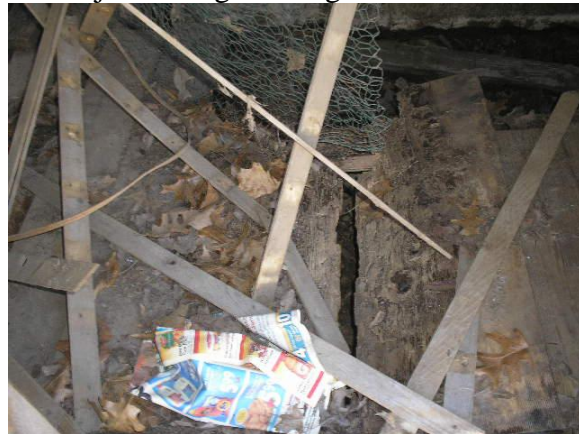
6.
7. Metal Simpson joist hangers are needed throughout under deck.
8. Under the deck, the 2x2 wood ledger strips should have 3 nails under the ends of each joists, and they do not.
9.
10. Some deck posts are barely sitting on blocks that are just sitting on the ground.

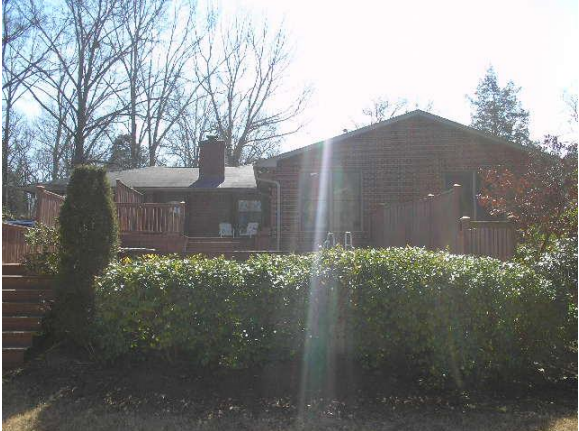
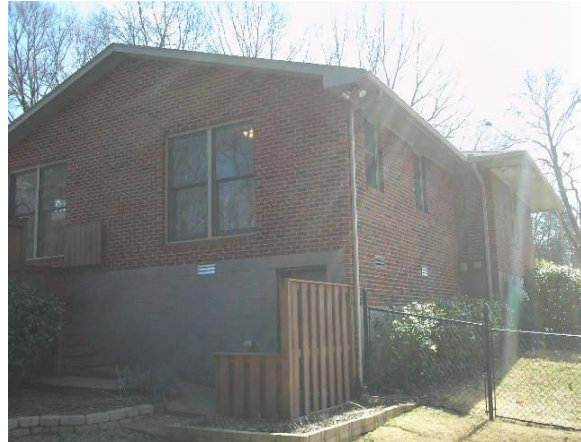
- 18.
19. Common cracking noted on concrete driveway, walks, and front porch.
20. Seal off under the outside package HVAC unit and its metal shroud to help keep rodents out of crawl space. Use heavy screen wire outside and sheet metal in crawl space. No signs of rodents were seen in the crawl space at this time, but there are daylight holes into crawl space at this HVAC unit at this time.
21. Some of the wood latticework is broken on the deck.
22. All shrubs should be trimmed at least 12" to 24" from the house to allow proper air circulation around the walls. Vines and other climbing plants can damage exterior surfaces by trapping moisture and by promoting another path for insects to enter the home. Outside electric panels must have at least 36" clearance in front of them for safety.

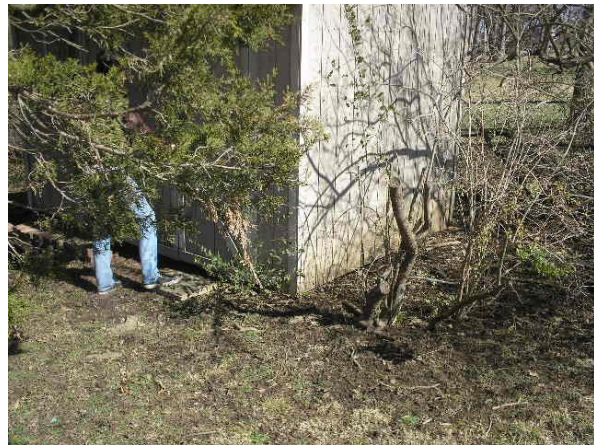
23.
24. Wood siding on the shed is touching the ground, which invites termites. There should be at least 6" clearance between ground and wood.

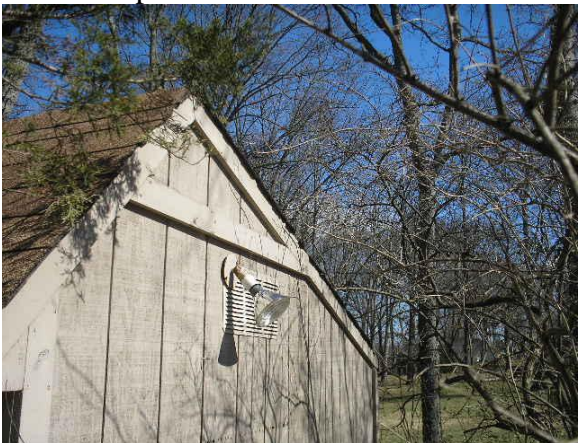
25.
26. There is termite damage on the rear edge of the shed.
27. There is a pile of wood behind the shed that can invite termites.

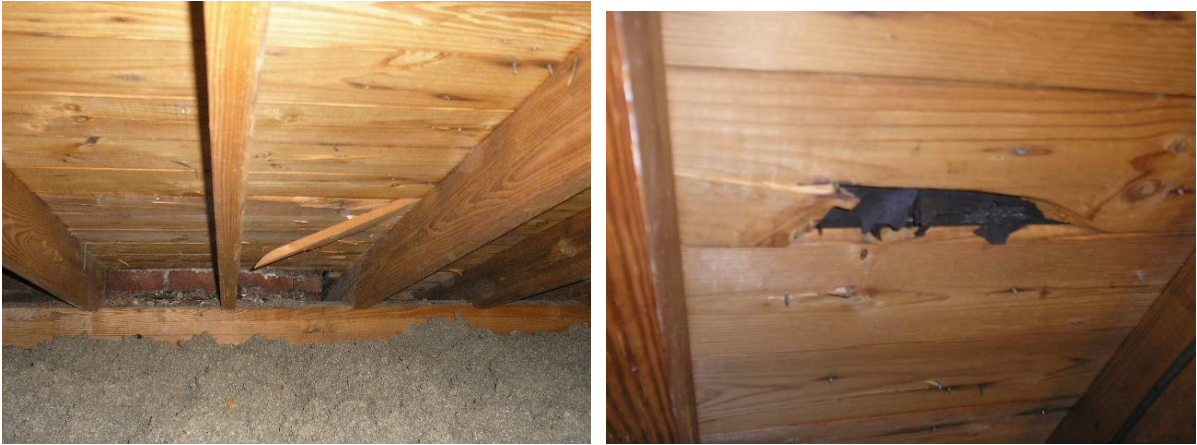
- 4.
5. Seal up gaps in metal flashing around chimney.
6. Some roof planks are busted in the attic, which is common, but should be repaired. If someone steps on these spots, they could step through the roof.

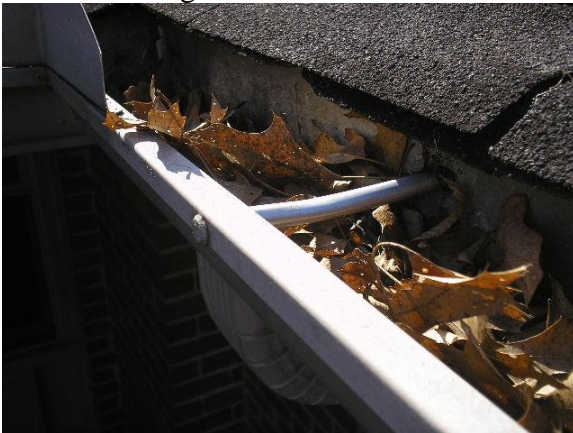
1. Clean out the gutters.

- 2.
3. Add leaf guards.
4. Gutters, downspouts and drains are often ignored. Poor maintenance on these items can cause more damage to house exteriors and foundations than possibly any other component. Gutters and downspouts should be cleaned at least once a year and kept in good condition to ensure the water flows through the gutters to the downspouts and well away from the house.

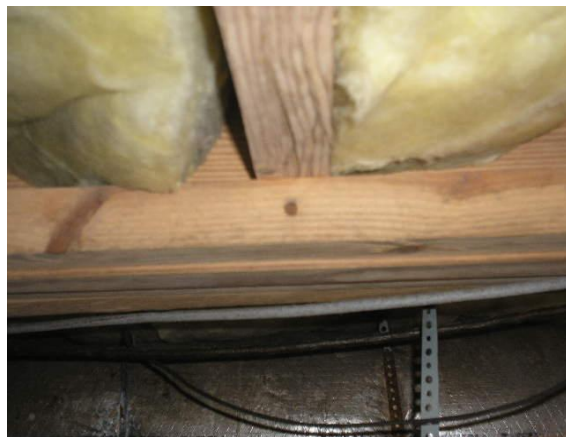
6. In attic, the front right valley rafter is sagged a little in middle where there is a large knot that is cracked and partially separated. Add a 2x4 wood stud kicker with a stiff-back, under the weak sagged spot under this front right valley rafter. Set the bottom of the support on top of a wall below.

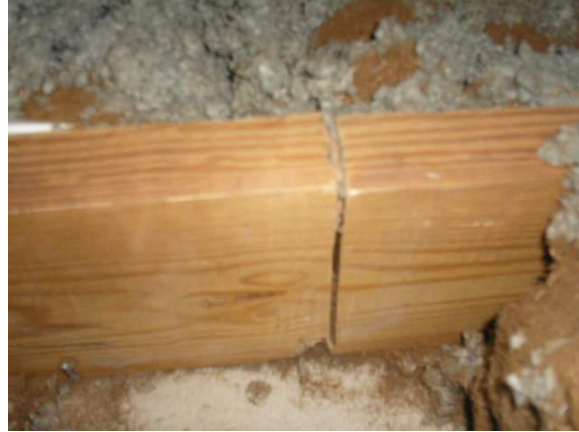
9. In the left center attic, some 2x6 ceiling joists are cut almost all the way in two.

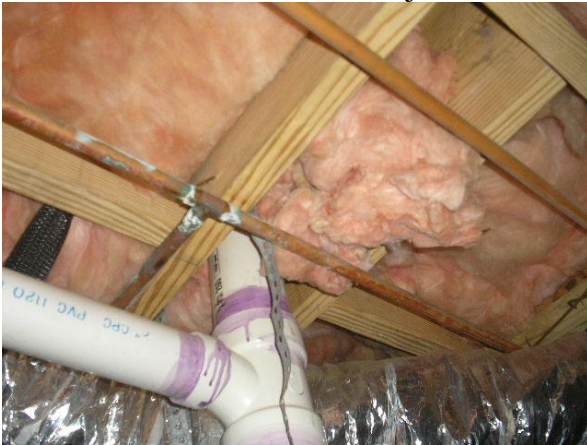
10.
11. Under the master commode in the crawl space, a floor joist has been cut completely in two, and blocking added. Add metal Simpson joist hangers on all perpendicular connections at these headers, cut ends of floor joist and blocking.

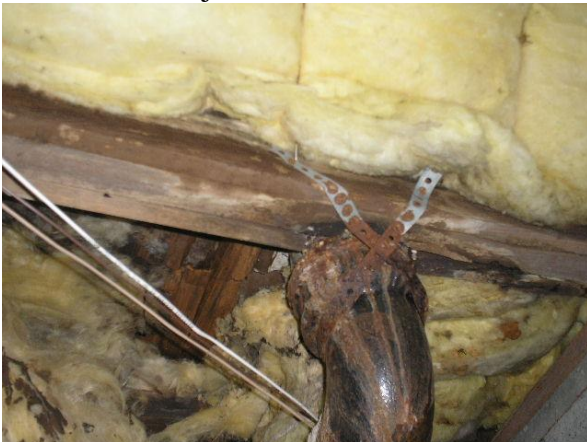
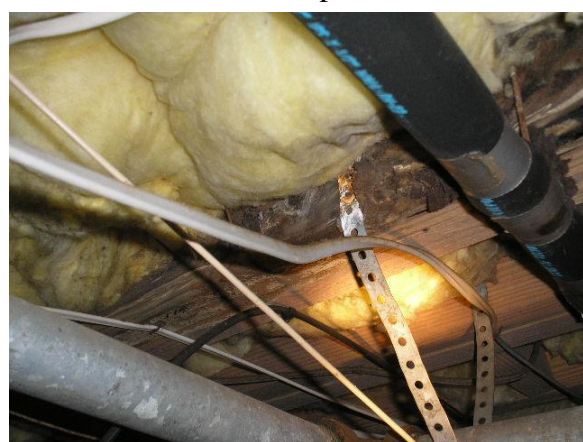
12.
13. Floor and floor joist are rotted some under hall bath. Reinforce rotted spots here.

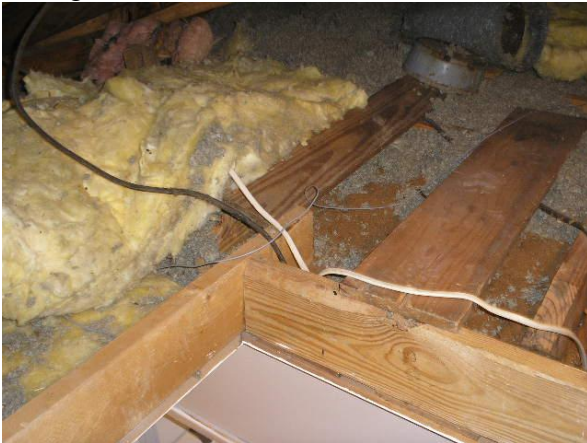
13.
 14. There is some frayed wiring by the attic access hole. There is not supposed to be any exposed wiring within 6 feet of the attic access hole. Repair and protect wires.

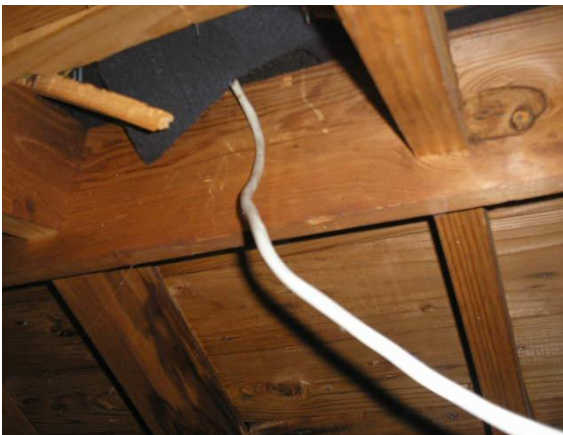
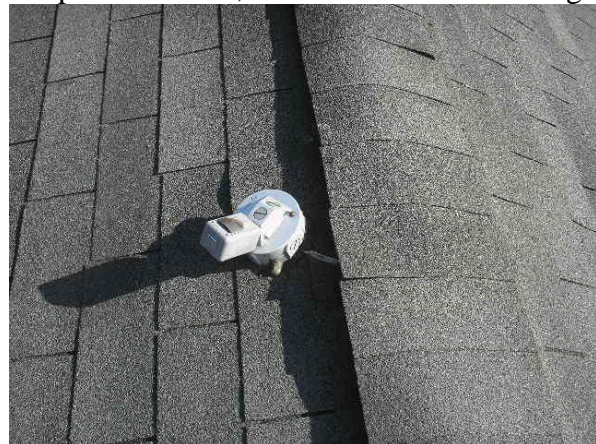
15.
 16. In the attic, the electrical wiring needs to be stapled down flat. It is a trip hazard!
 17. In the attic, wires need to be stapled within 12" of covered junction boxes; like in the left attic.
 18. In the attic, there is a wire running up out the continuous ridge vent to a photocell on the roof, in front of the sky light. Wire should be stapled to rafters, and rated for direct sunlight.

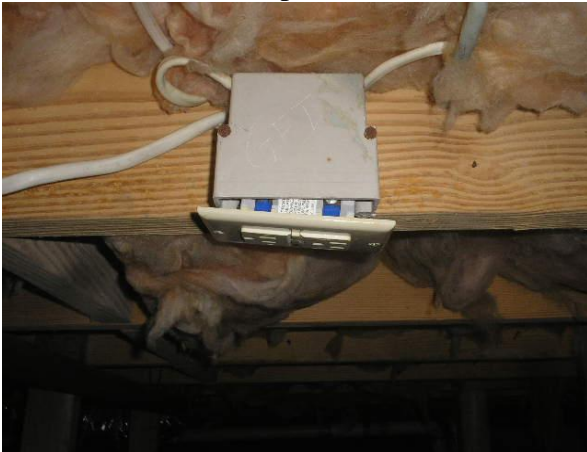
22.
 23. There is an open slot in the bottom of the main electric panel in the laundry. Install blank or breaker in the open slot.
 24. Electric panel is low to the floor in the laundry room, since this used to be the garage.
 25. In the walk-in crawl space, a GFCI outlet is hanging out of its box on the floor joist.

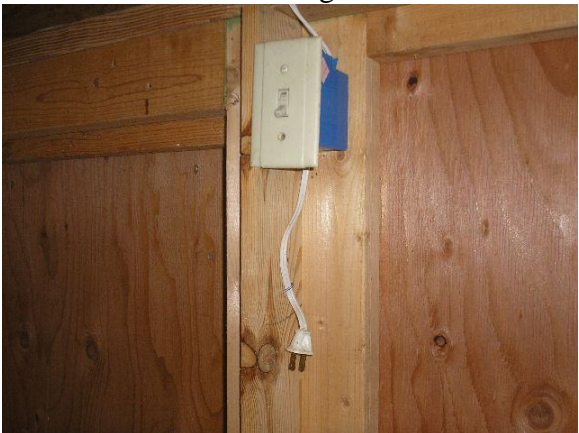
26.
 27. There are exposed electric wires and splices under deck that are not in conduits, and do not appear rated for exposed exterior use. All wire splices should be in covered junction boxes.
 28. Wiring in the shed appears to just be an extension cord run to a light switch. I do not recommend this since it is small wires, and are not grounded. There is no power on to shed at this time. It appears it has been powered by running an extension cord to it from the house. We did not test the wiring in the shed.

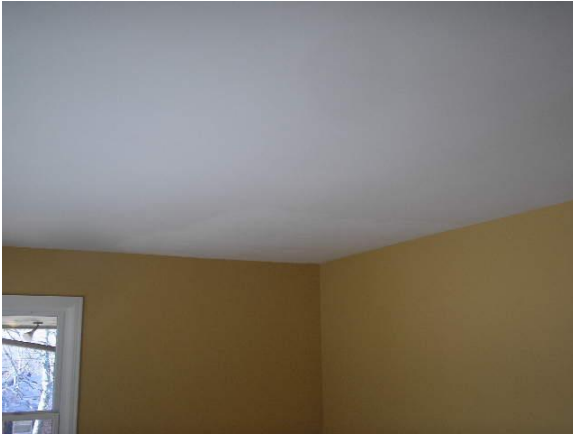
1. Different color white paint noted on the ceilings in the living room and dining room.

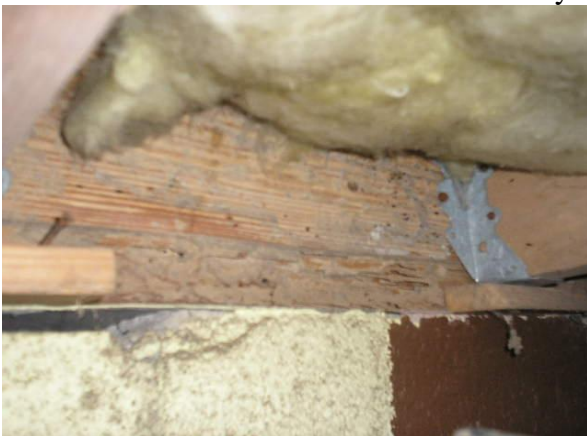
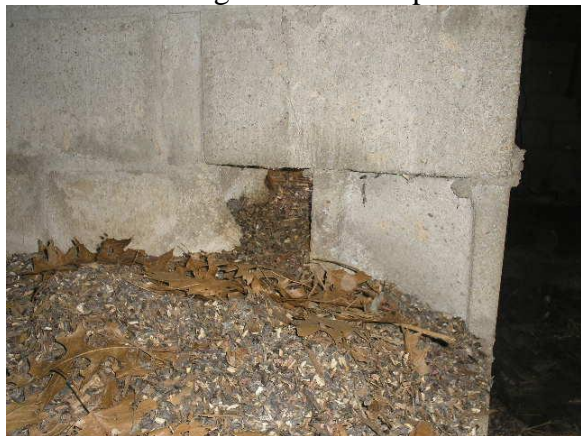
1. Hall bath commode is leaking into the crawl space. There is water on top of the plastic. See **PLUMBING** notes above.
2. Floor is rotted out under the hall bath commode some.
3. There has been a leak under the right hall bath sink. There is some mold-like substance and rot on the wood floor joists. See **STRUCTURAL** notes above.
4. There is some fungus in the bottom edges of some floor joists, like in the rear center crawl. This fungus can severely damage wood floor joists. Get the vapor barrier over the ground better.
5. There is termite damage in the floor joist/beam under the wall between the old garage and the house. This can be seen above near where you crawl into the right rear crawl space.

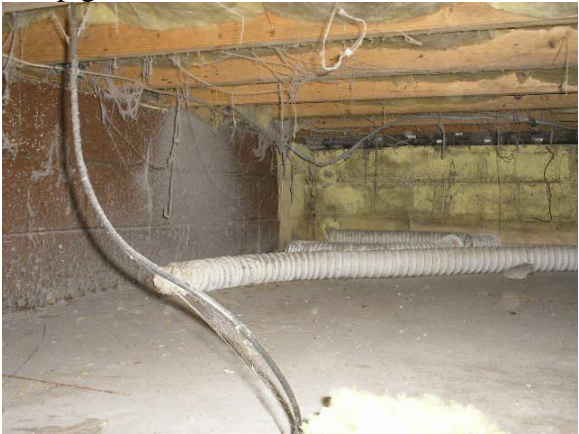
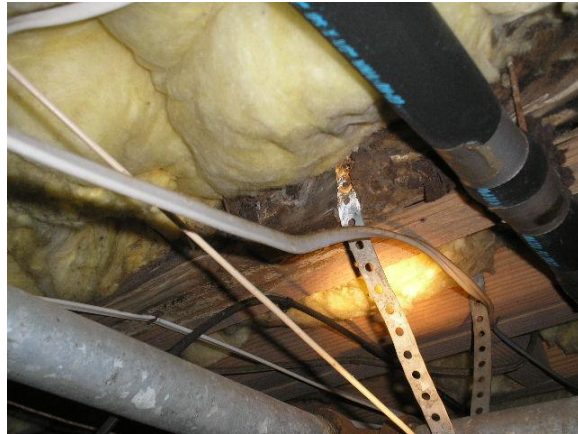
1. There is some mold-like substance on exposed portions of most of the wood floor joists, and on bottom of the batt insulation between the floor joists. It appears worse above the bare damp ground.

- 2.
3. Per a specialist I know, it is best to remove the mold than to treat it with Tim Bore or Bore Care like several pest companies now do.
4. Mold is a fungus---a parasitic plant lacking chlorophyll, a rigid cell wall, leaves, true stems & roots. Mold is multicellular, and it is composed of thread-like hyphae.
5. Molds spores can cause serious health problems even if the spores are dead or dormant (inactive while waiting for more moisture to resume growth).
6. Even the smell of dead or dormant mold can make some mold-sensitive persons ill.
7. There are no legal mold exposure limits.
8. Sampling for mold can be referred to a qualified microbiologist.
