**1234 Sesame Street., Franklin, TN**

## **A+ HOME INSPECTIONS**

## **HOME INSPECTION REPORT**

Evaluation of property located at: **1234 Sesame Street., Franklin, TN**

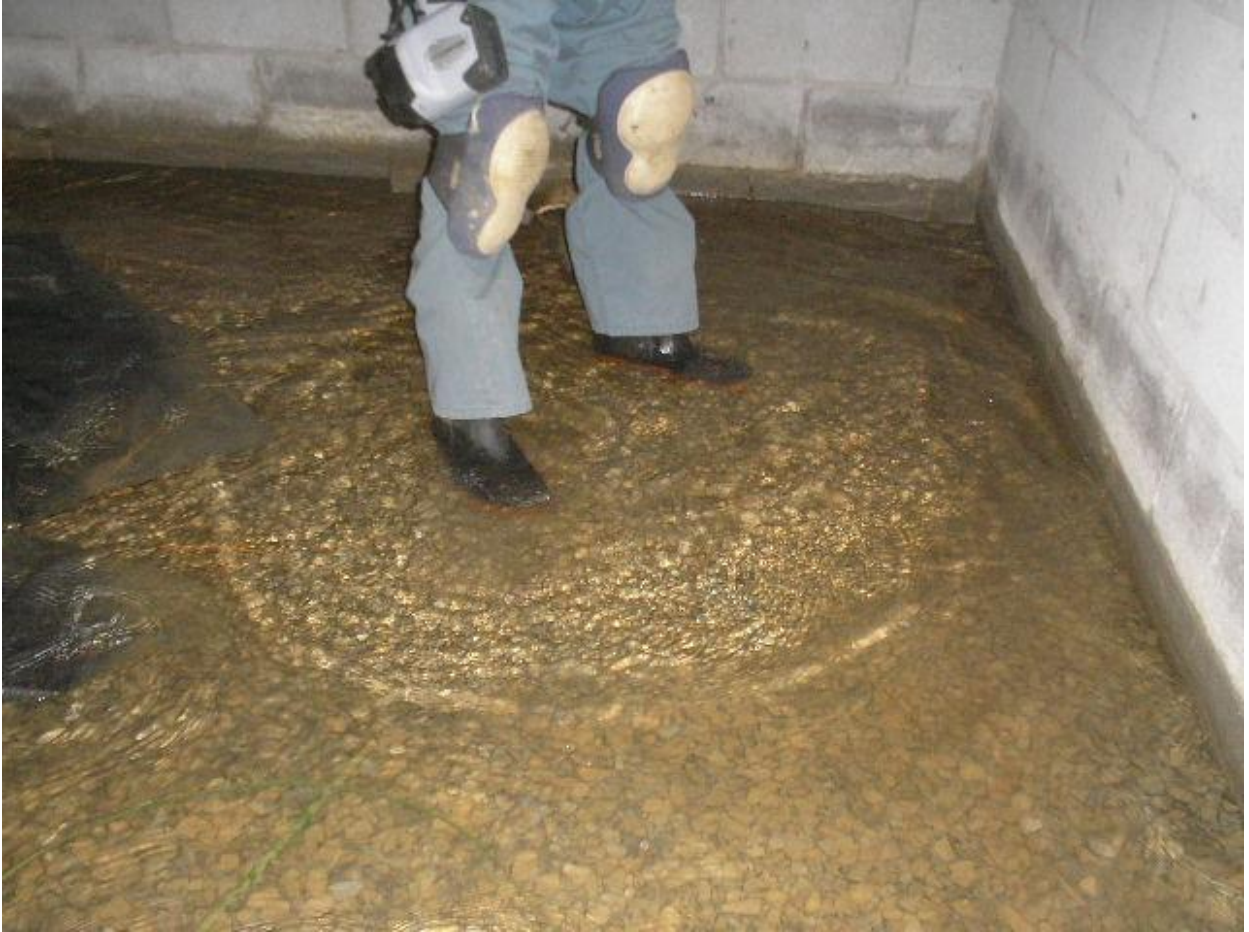
1. This home is built on a lot, which slopes from the house in all directions. But there are a few flat spots up near the house.
2. Water is standing in the front left crawl space at this time. See CRAWL SPACE notes

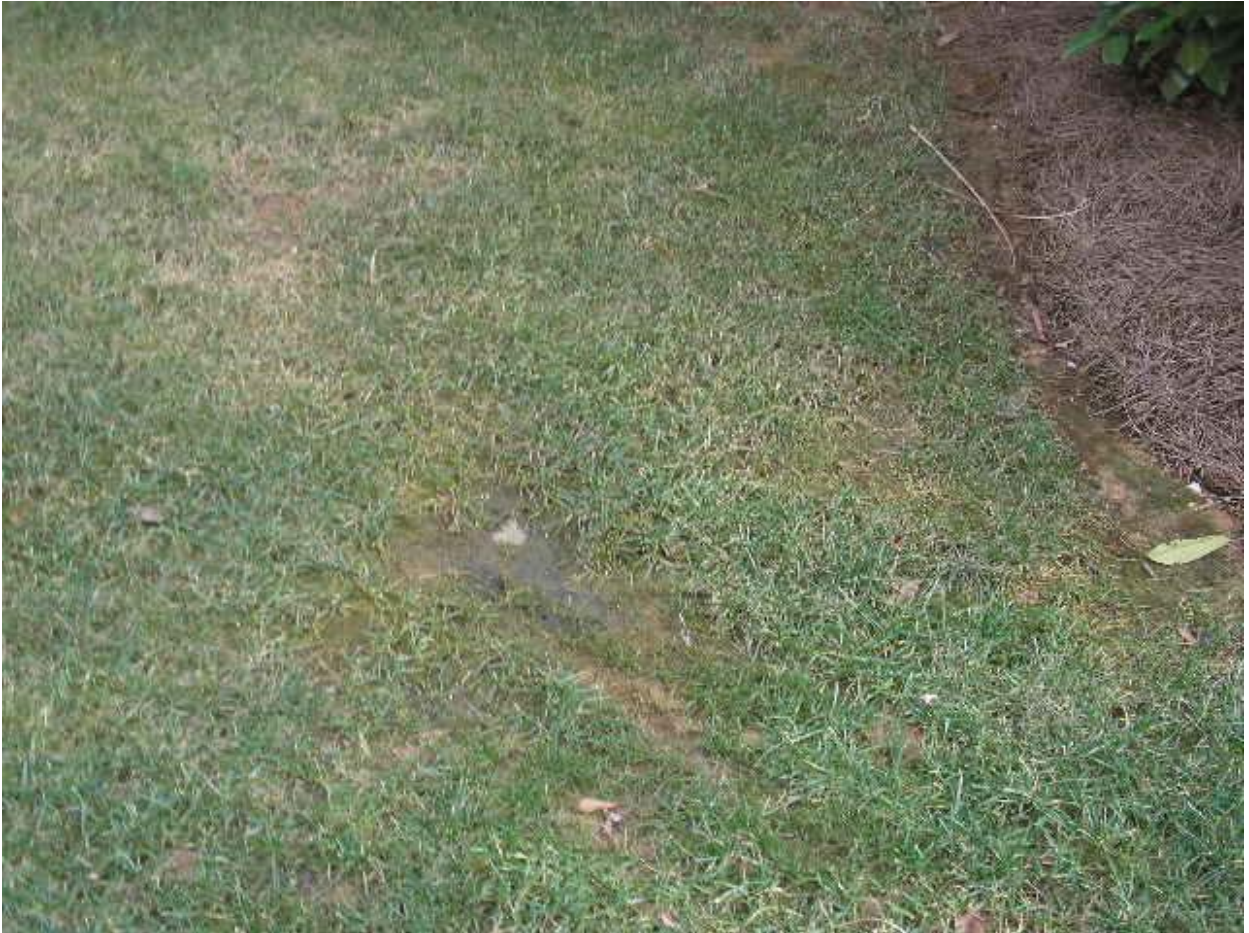
- 3.
4. Water appears to pond in a couple of spots in the left side yard, about halfway between the houses.

9. Adding sloping compacted clay dirt up against house to any low lying areas around the foundation where ground settles, will help kick water away from house.

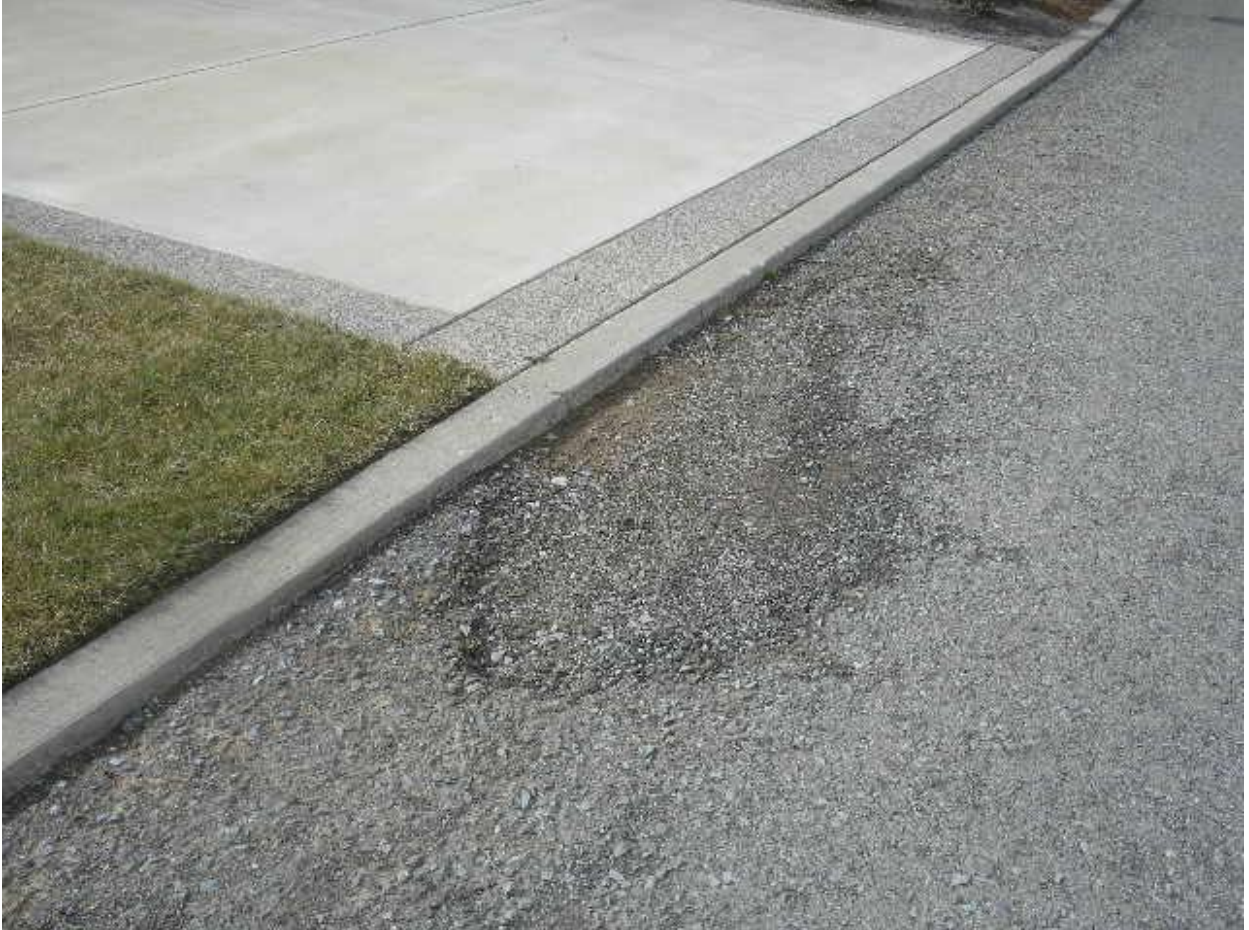
1. In the street at the rear of this concrete driveway, the asphalt binder has failed, and some mud has come through the asphalt pavement. This binder should be dug out and repaired prior to the final asphalt topping.

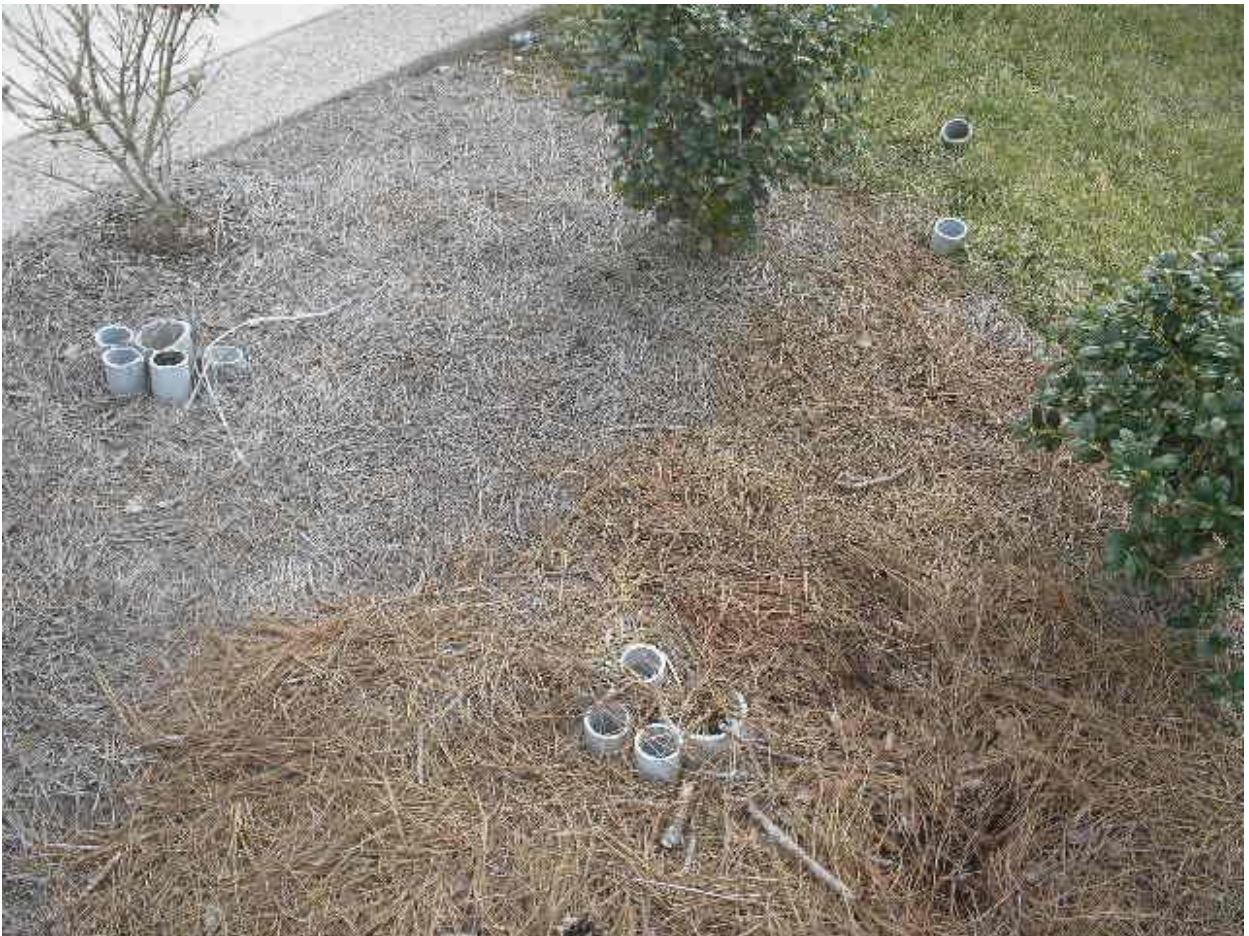
- 2.
3. There are about 12 different conduits stubbed up out of the ground in the rear left yard by the electric transformer. These need to be removed or at least sealed off. What are they all for?

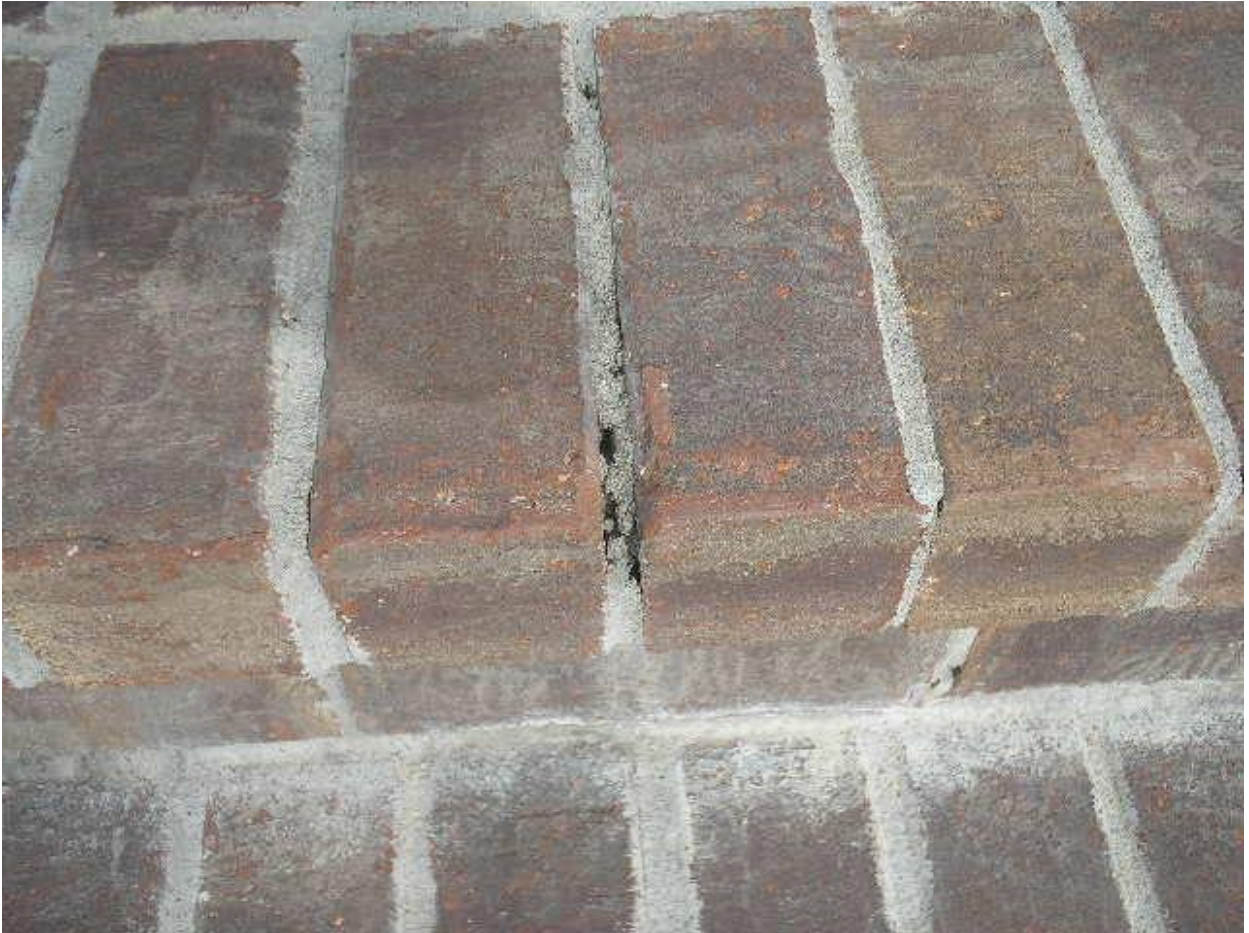
- 4.
5. Some mortar is missing in the middle of the brick steps on the front porch.

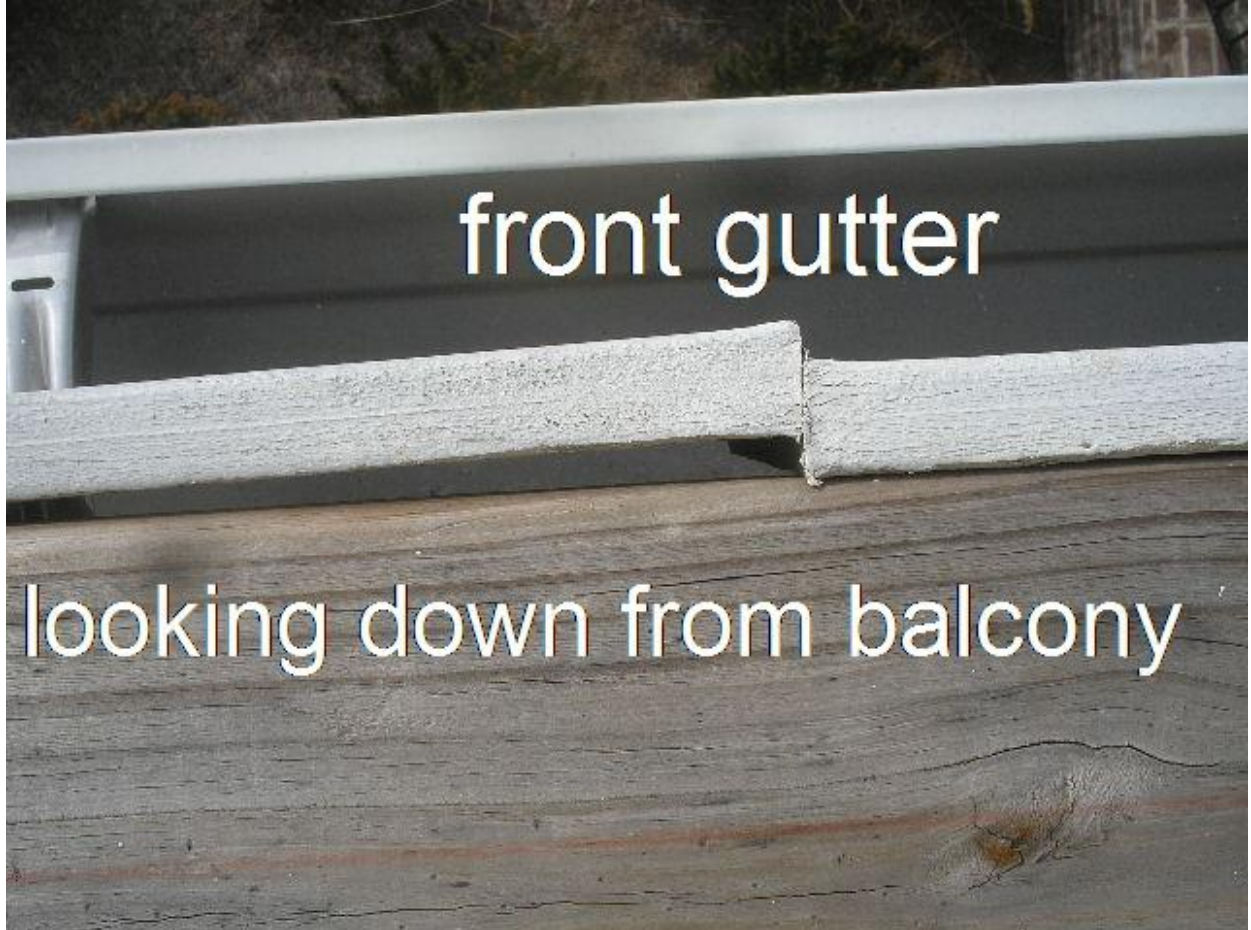
1. On the balcony above the front porch, the intermediate wood handrail posts are not attached to the wood decking. This is a FALL HAZARD!

2. These intermediate wood posts are just sitting on the front balcony here. When securing these loose intermediate posts, be sure to use short enough nails/screws to not damage the roofing below the wood decking planks.
3. On the outside balcony, one ½” gap noted between the walk boards on the front right corner.
4. One of the trim boards is pulled away from the front balcony; as seen from the front balcony above the front porch.

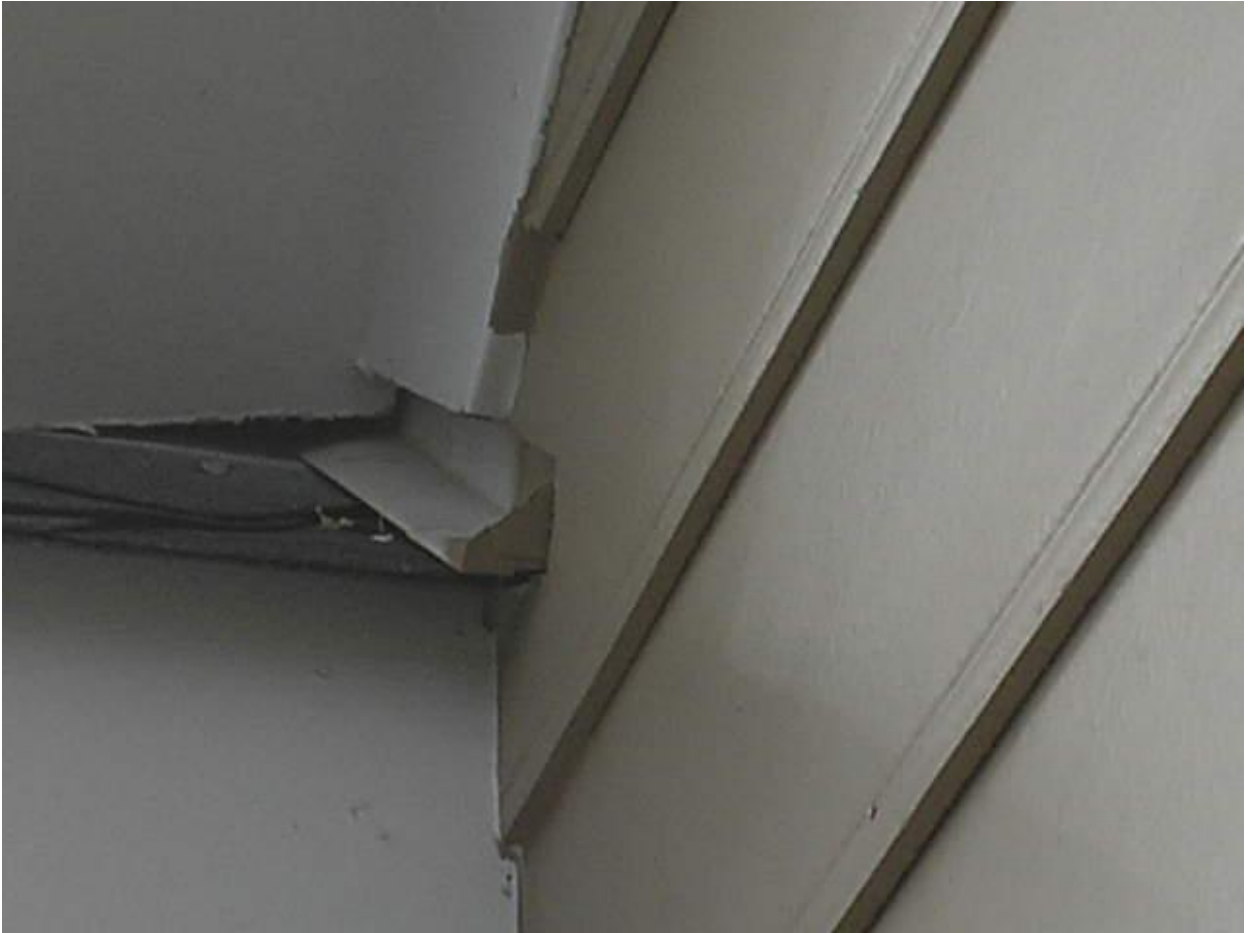
- 5.
6. Seal up gaps under eaves/soffit where soffit meet the roof shingles, where birds can enter; like on the front right corner above the front balcony,

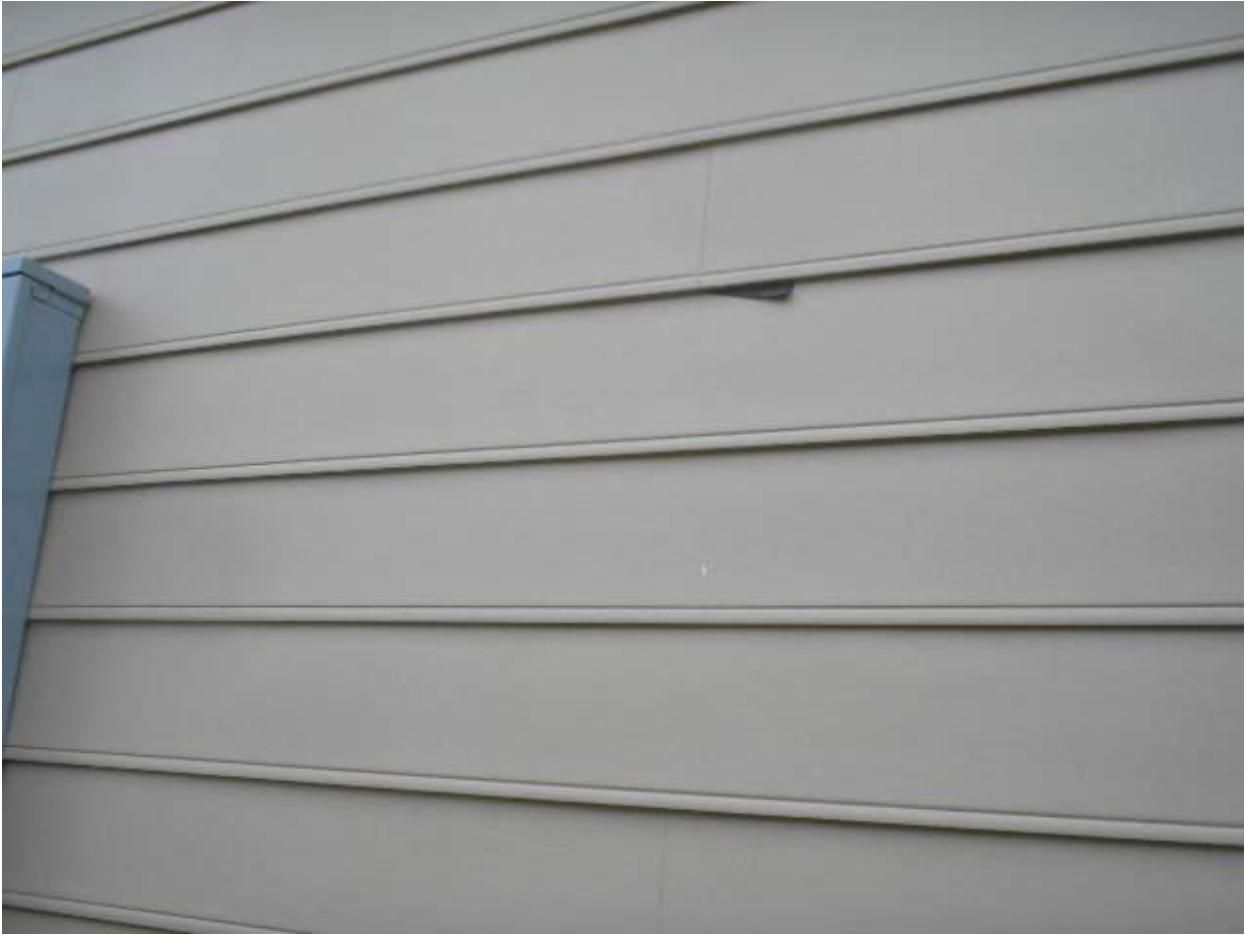
- 7.
8. Black sheathing (builder's felt) is sticking out from under some of the hardboard siding; like on the rear of the garage, and on the left side of the house,

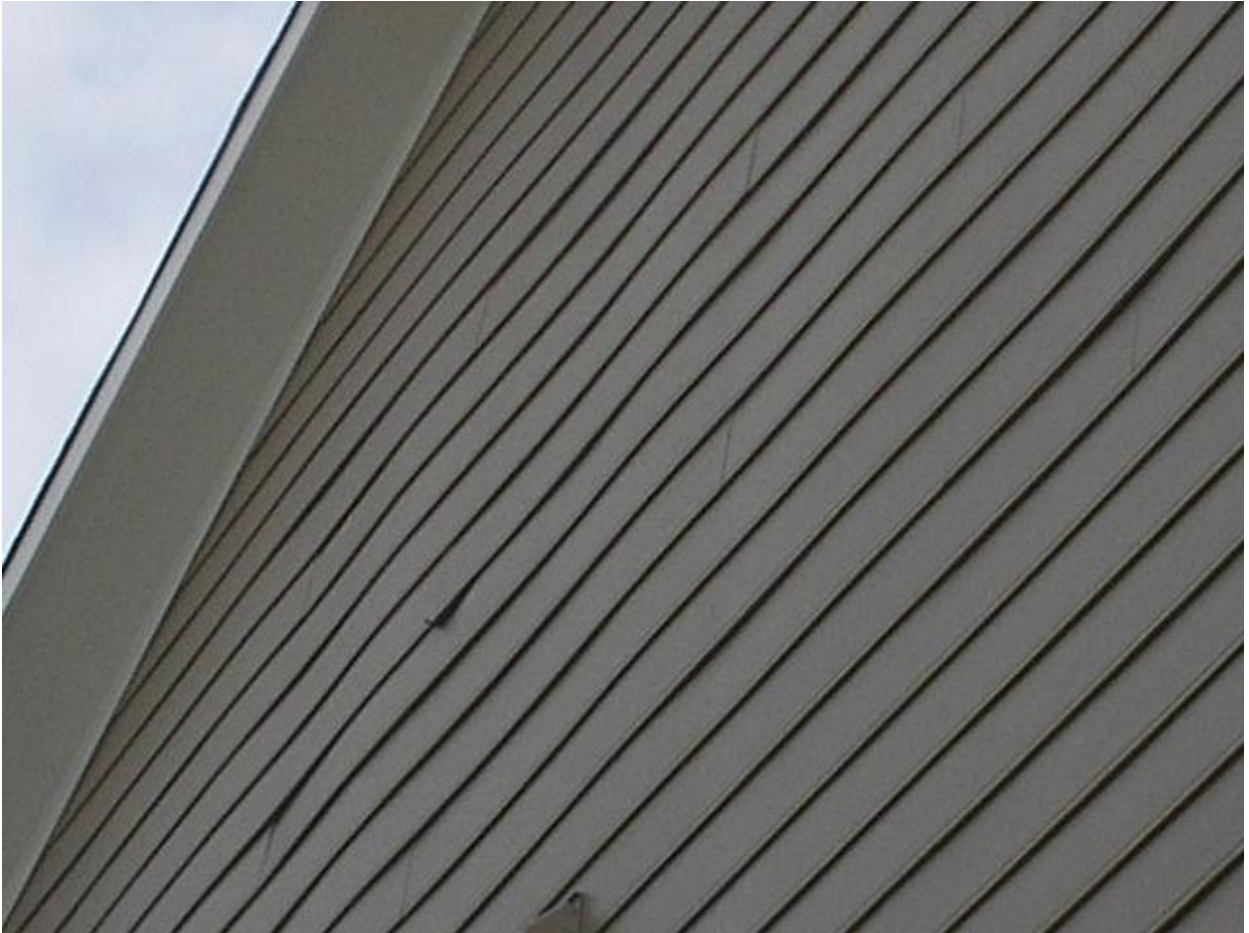
- 9.
10. Hardboard siding is wavy on the left end gable where some sheathing is sticking out.

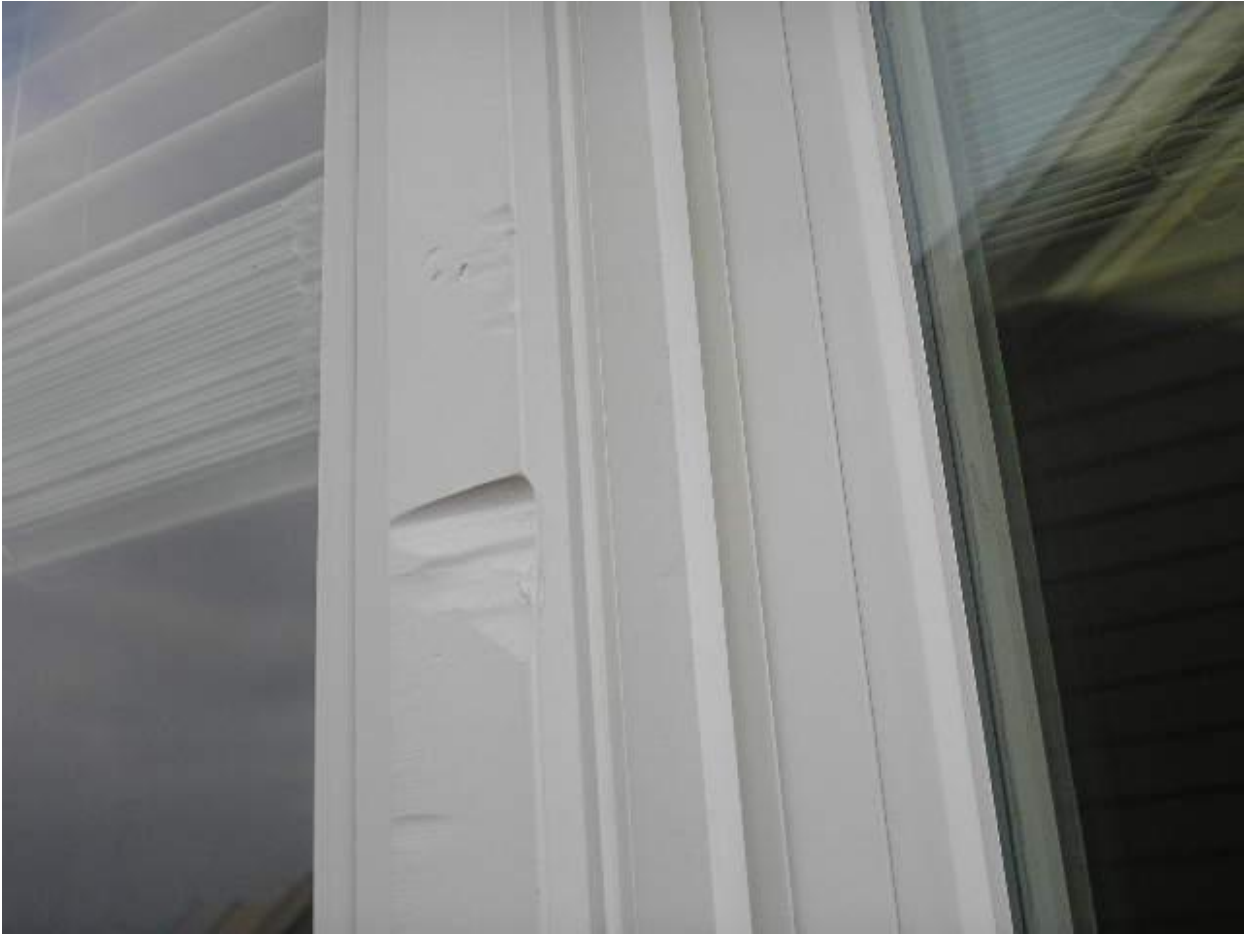
- 11.
12. Window screens are missing. Some are stored in the right attic. Buyer would like all window screens installed.
13. On the left side of the house, the 1x2 wood mullion between the middle and rear loft windows is dented in several spots.

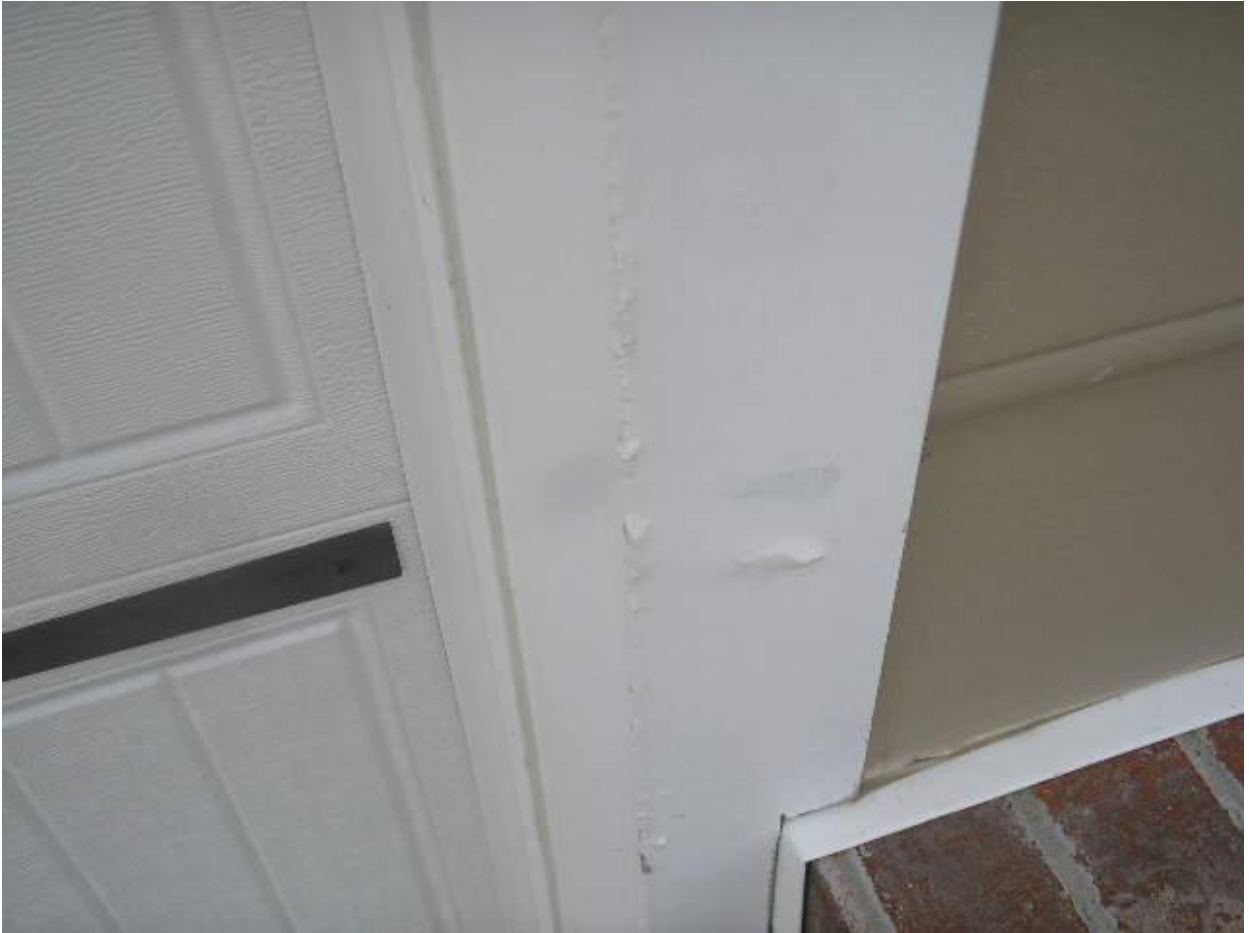
- 14.
15. Some exterior trim has raised nail bumps and rough edges, like trim around overhead garage door. Trim appears to be a type of hardboard man-made trim here.

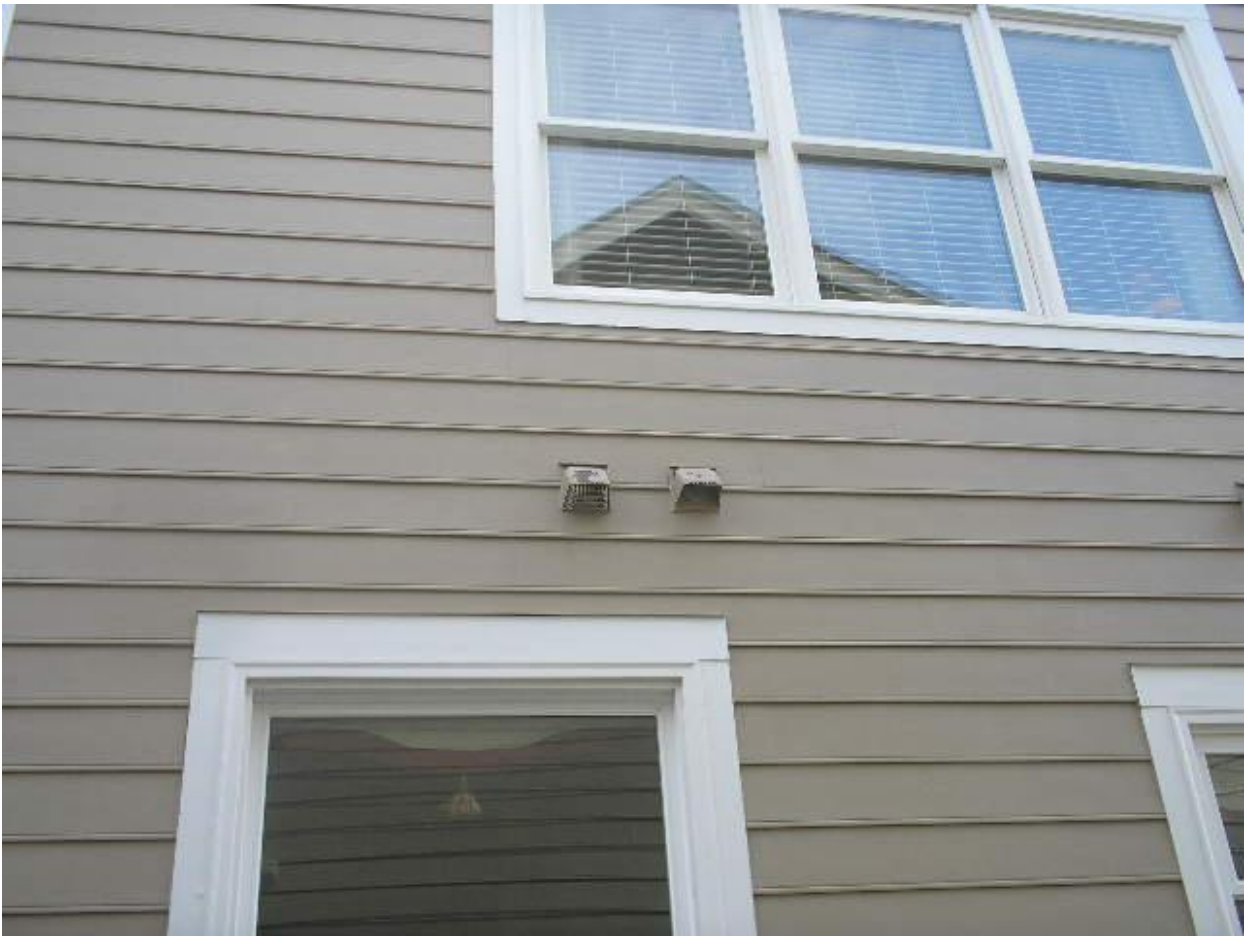
23. Brown paint has come off the four outside vent hoods on the left side of the house.

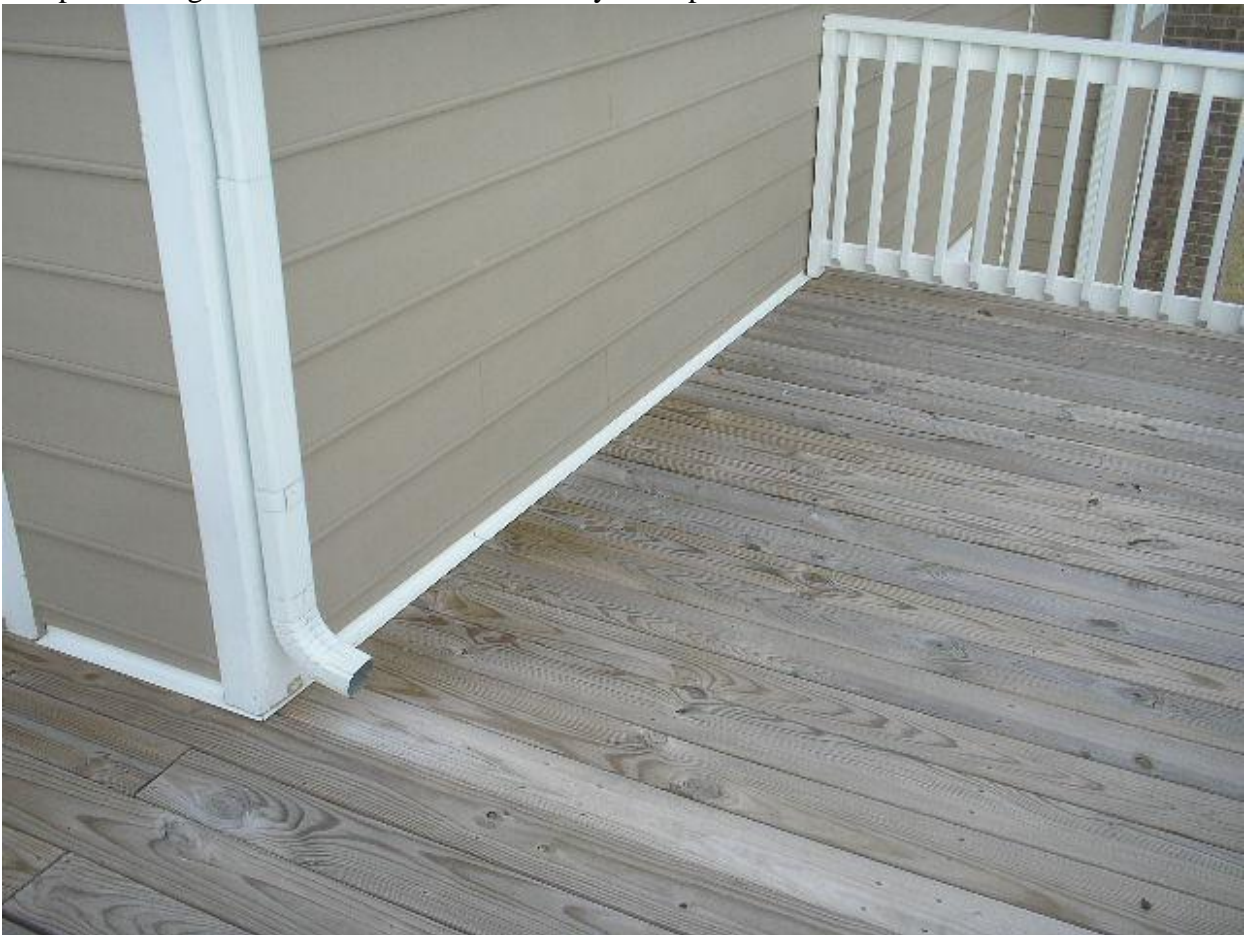
1. Front right downspout dumps out onto the front wood balcony floor and runs across membrane roof under the decking. An downspout elbow and matching downspout pipe should be added to extend this downspout back along side on house above the balcony to dump into the gutter on the back of the balcony/front porch roof.

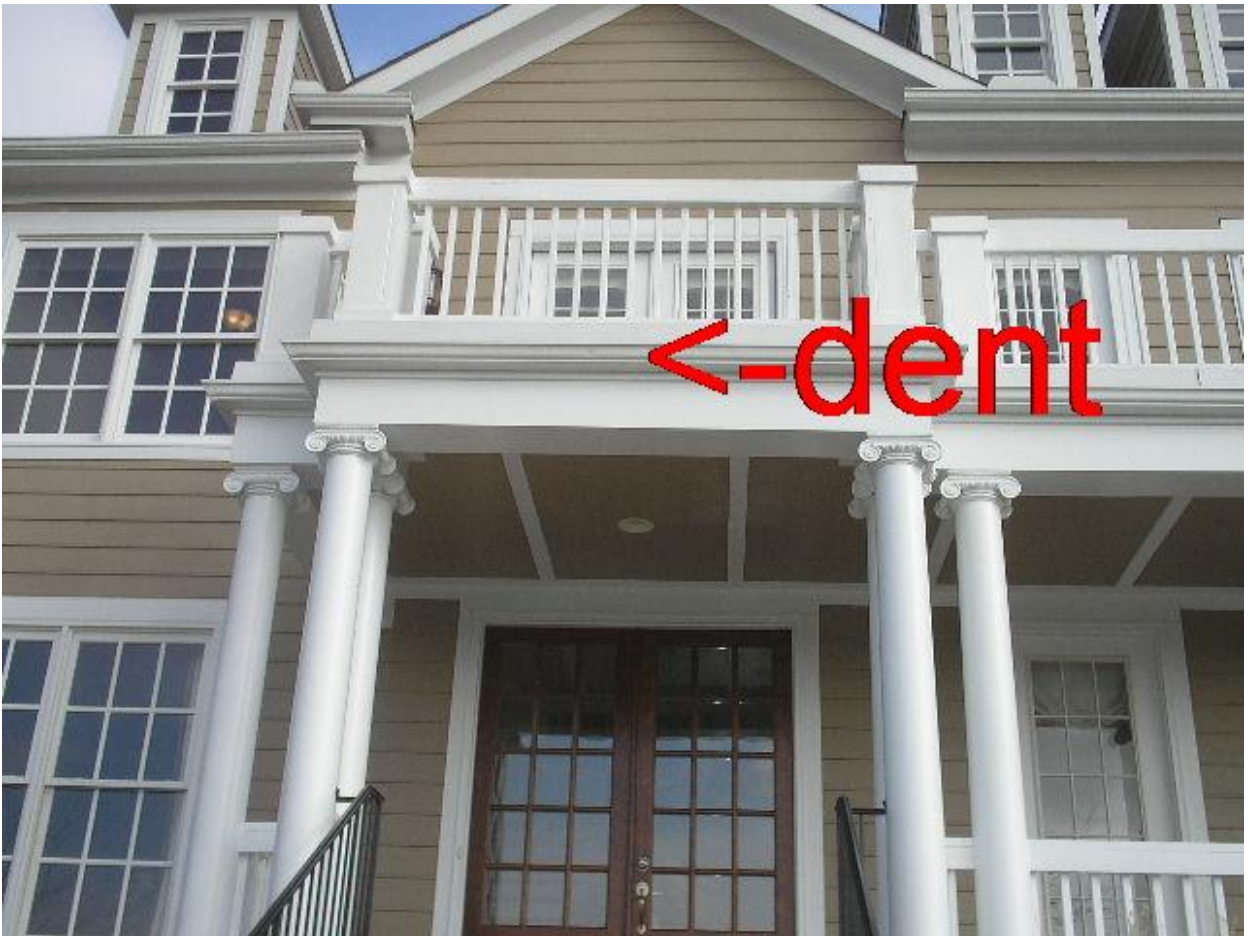
- 2.
3. Gutter is dented above the front porch steps. This is a focal point of the house, so it should be replaced.

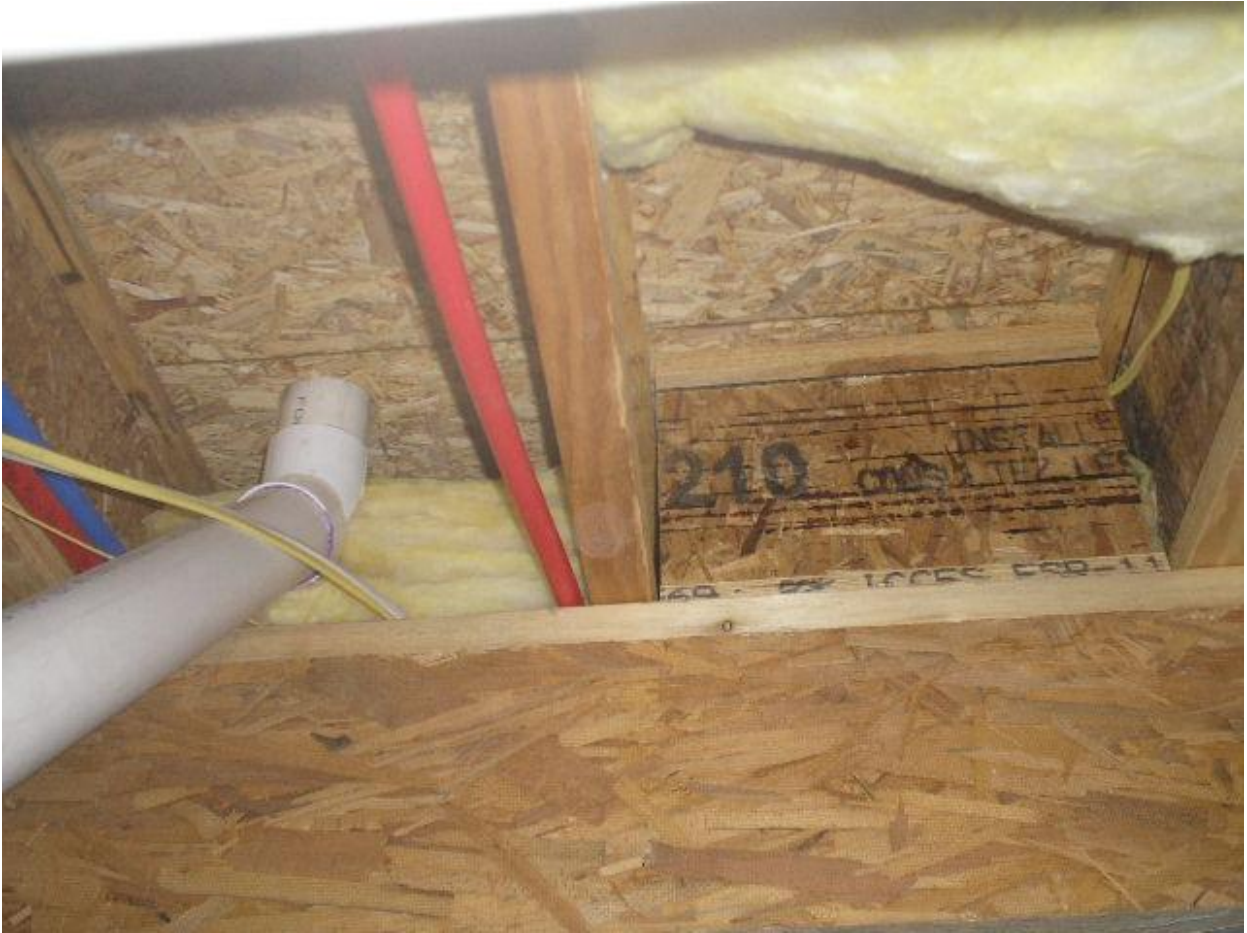
1. In the crawl space, the manufactured "I"- floor joists require panel blocking or 2x4 squash blocks between the I-joists, above the beams under all load-bearing walls.
2. In the crawl space, a few pieces of wood panel blocking that were nailed in place, are now knocked out; like two at the kitchen downdraft exhaust fan and the drain line next to it.

- 3.
4. Since panel blocking will not fit into bays where ductwork and piping run through these spots where panel blocking was above the beams, the manufacturer allows 2x4 squash blocks to be installed in lieu of panel blocking. There should be a 2x4 squash block on both sides of each bay above the beams, where the panel blocking is missing.

5. There should be no gaps at top or bottom of the 2x4 vertical wood stud squash blocks. They should sit firmly on the girder beam and be snug at their tops to the sub-flooring above them.

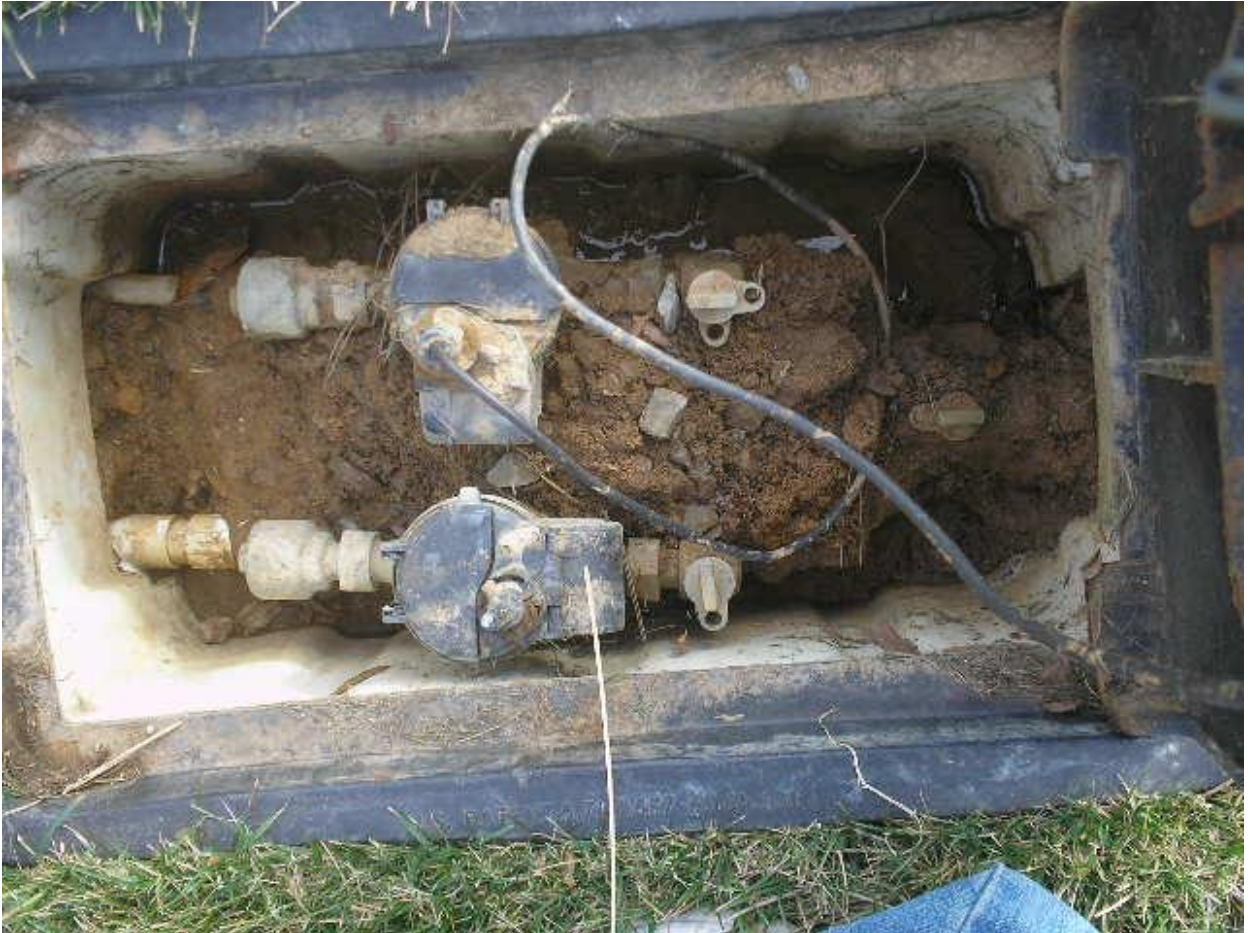
1. Some water is standing in the water meter pit in the front yard. Ensure it is ground water and not a domestic water leak.

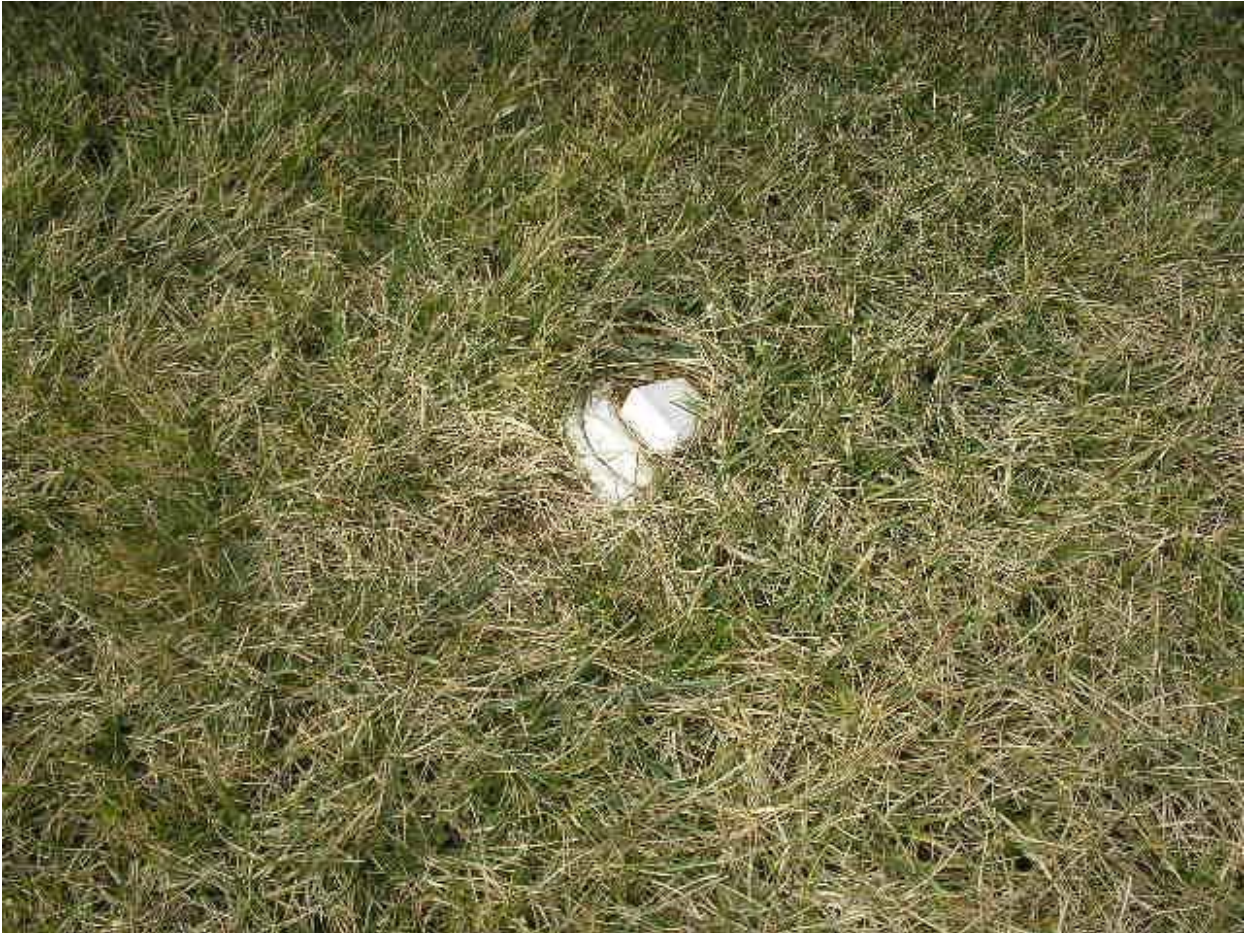
2. Half bath commode makes a buzzing noise when filling. It sounds like noise is coming from the filler kit in the commode tank.
3. Half bath commode base is shimmed pretty high in front, but does not appear to leak or wobble at this time.
4. PVC sewer cleanout in the right yard, near the rear right of the chimney, is bent over at about a 45 degree angle in the ground. It appears it was run over during construction. So, it may be broken off where it joins the main pipe underground.

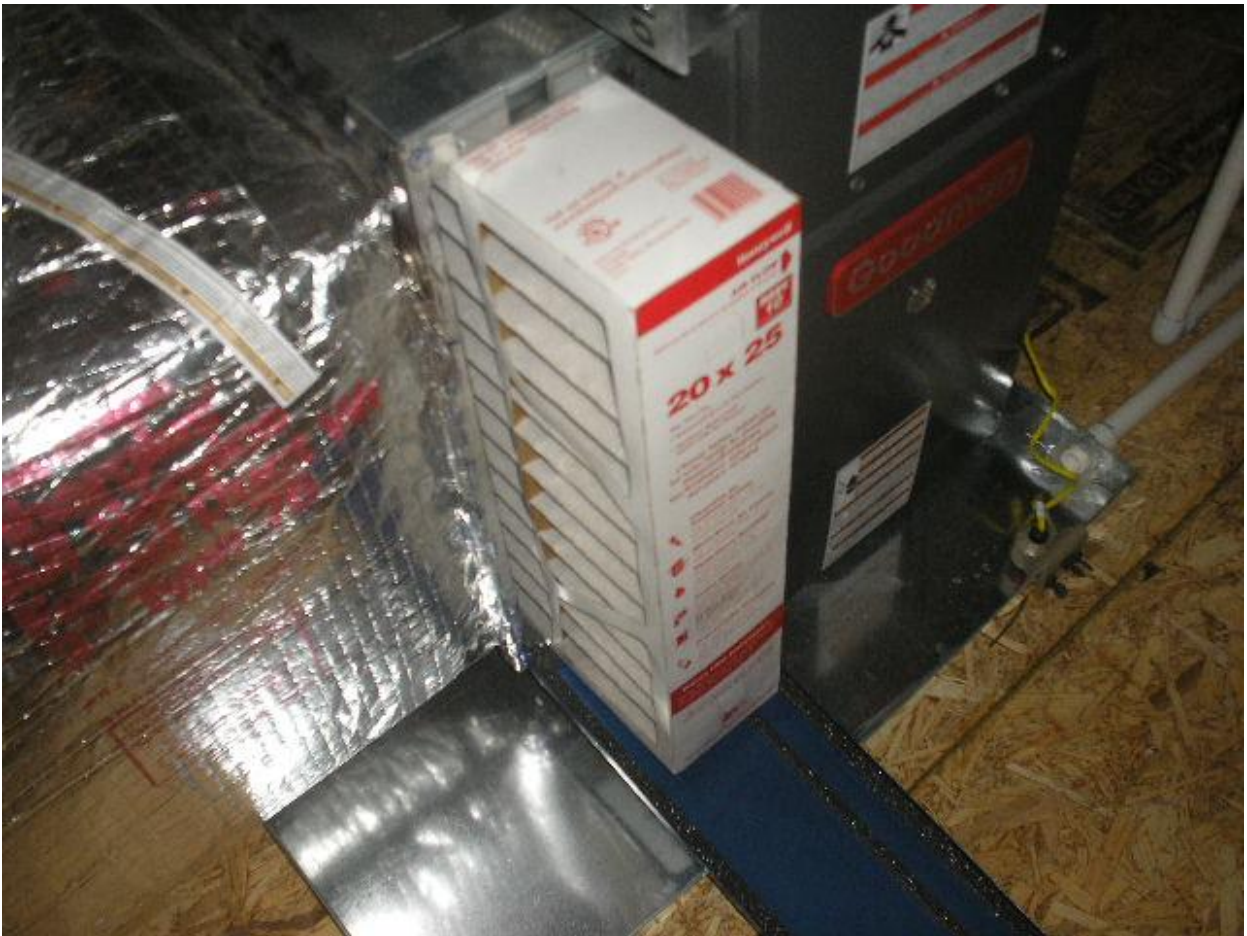
1. There should only be return air filters at the return air doors, or the 6-12 month thick filters in their Honeywell compartments beside the HVAC units in the attic. Now, there are filets in both places.
