**1234 Sesame Street., Franklin, TN**

## **A+ HOME INSPECTIONS**

## **HOME INSPECTION REPORT**

Evaluation of property located at: **1234 Sesame Street., Franklin, TN**

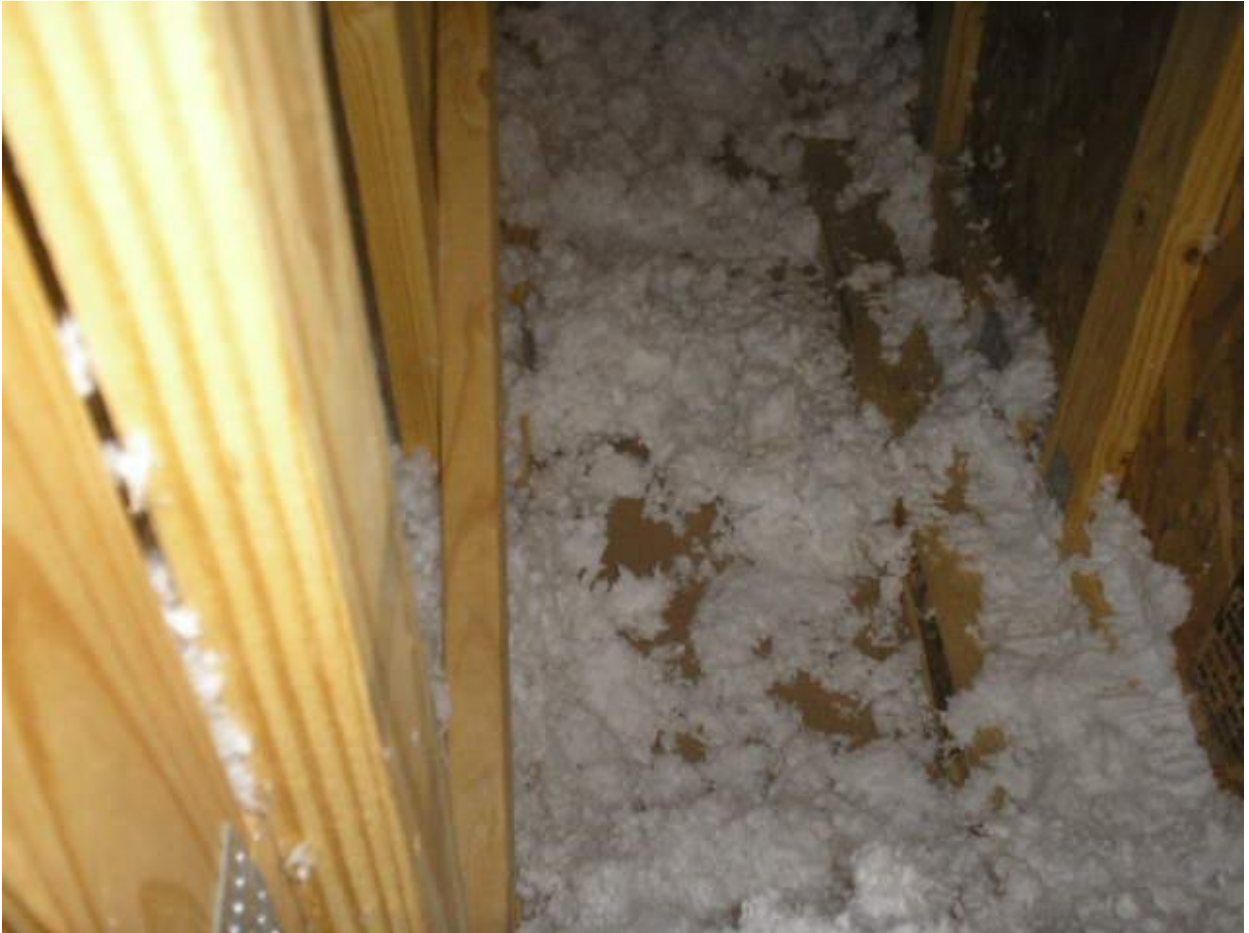
1. There are a lot of long sharp nails sticking through the side gable's OSB sheathing into the attic.
2. Level out the blown insulation in the right upper attic so it is at least 10" deep. Drywall ceiling is showing places here. Why was it pulled back? It is near the chimney. More blown insulation may have to be added here.

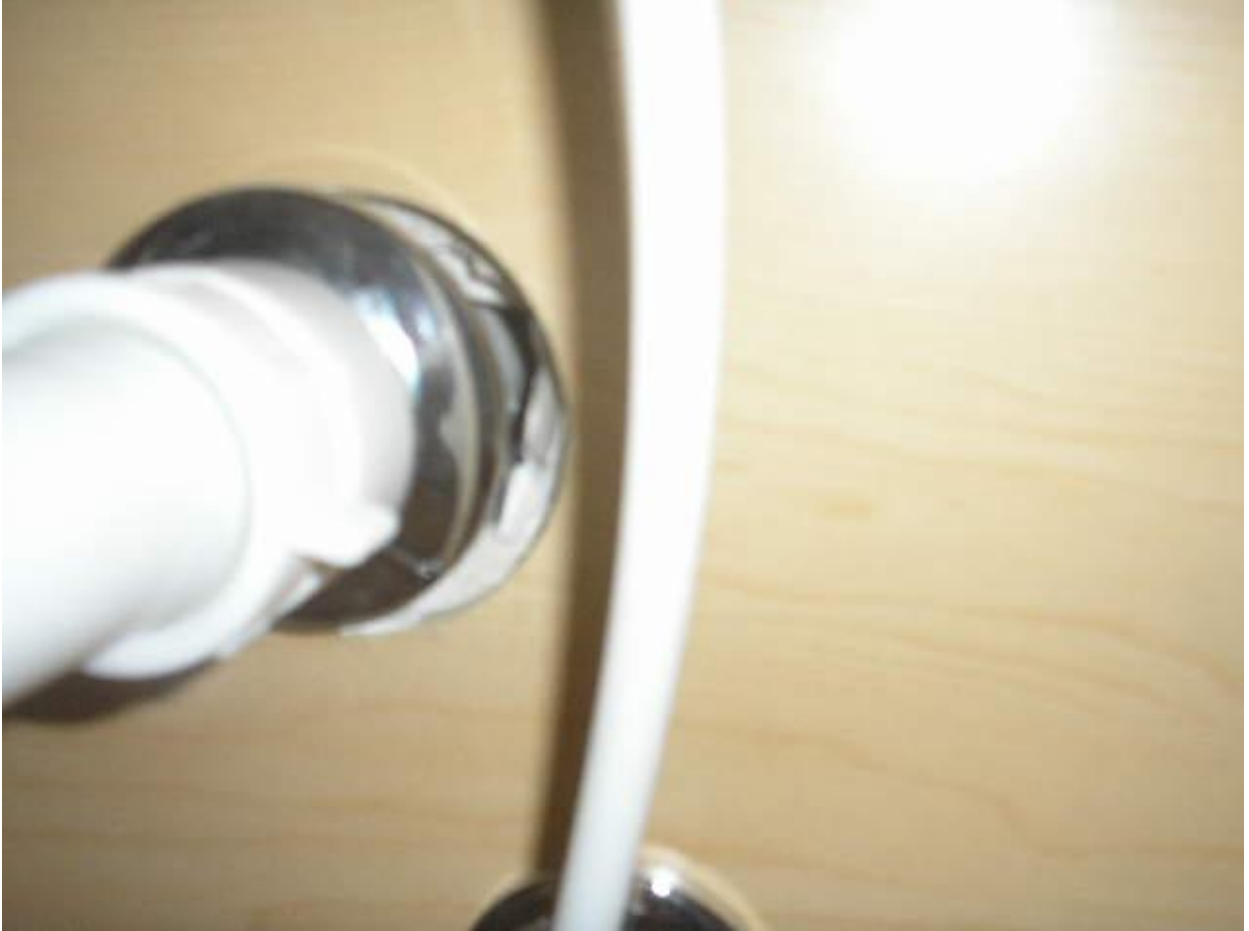
1. Under the right vanity cabinet, seal up the gap around the drain pipe through the wall, and cover it with a larger escutcheon plate, similar to what is under the other vanity.

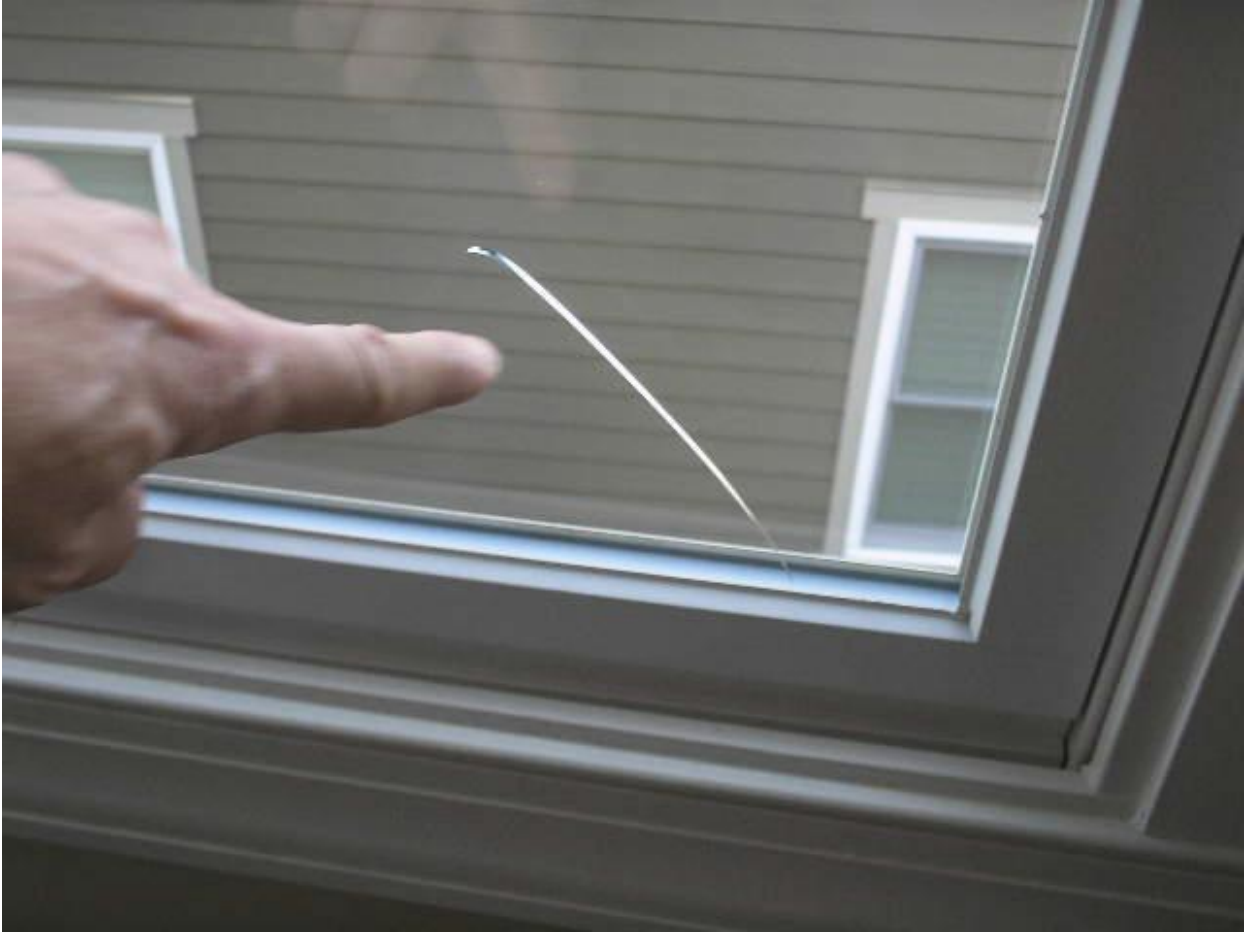
1. Front-most lower glass pane is cracked.

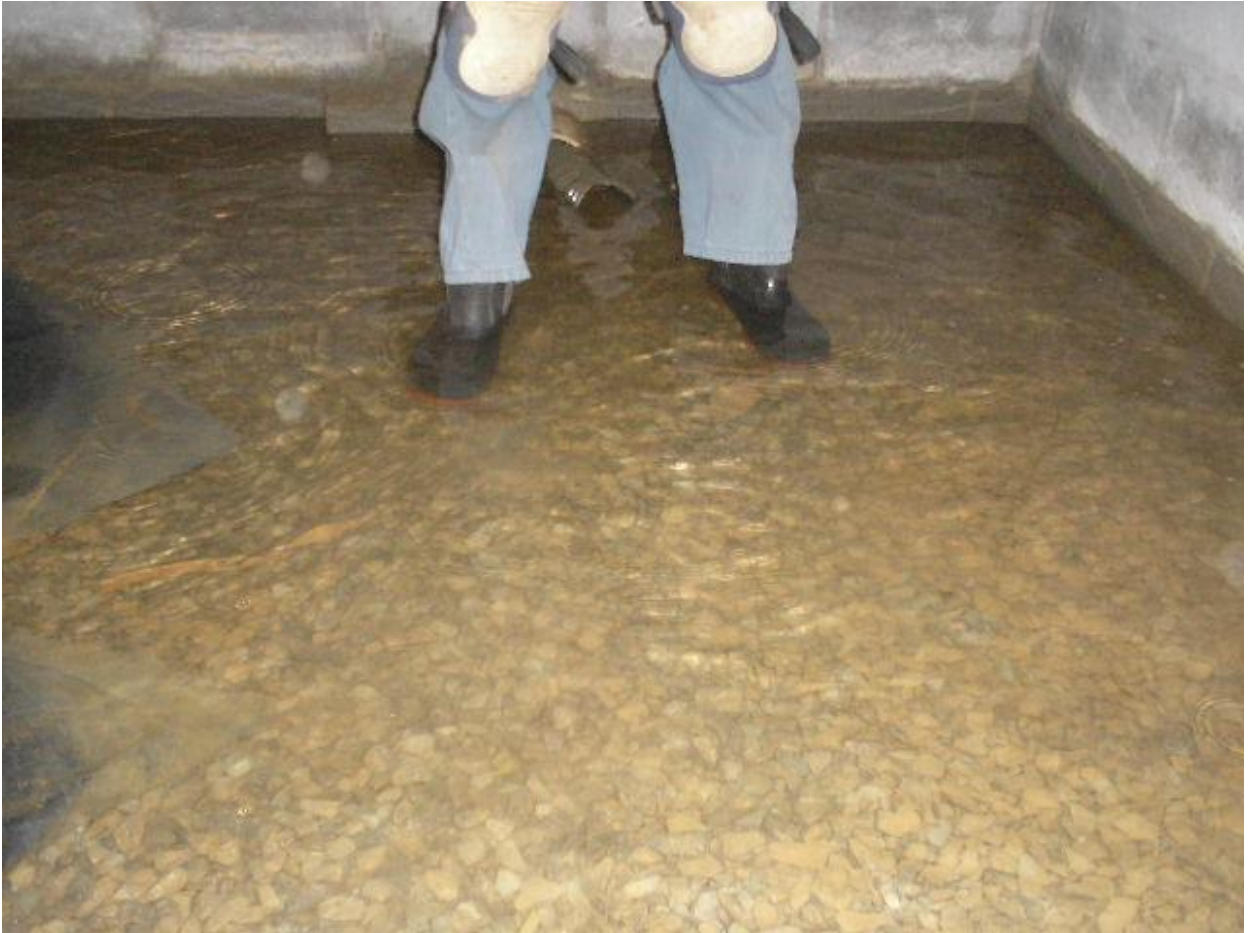
1. Water is standing about 4" deep in the front left crawl space under the dining room.

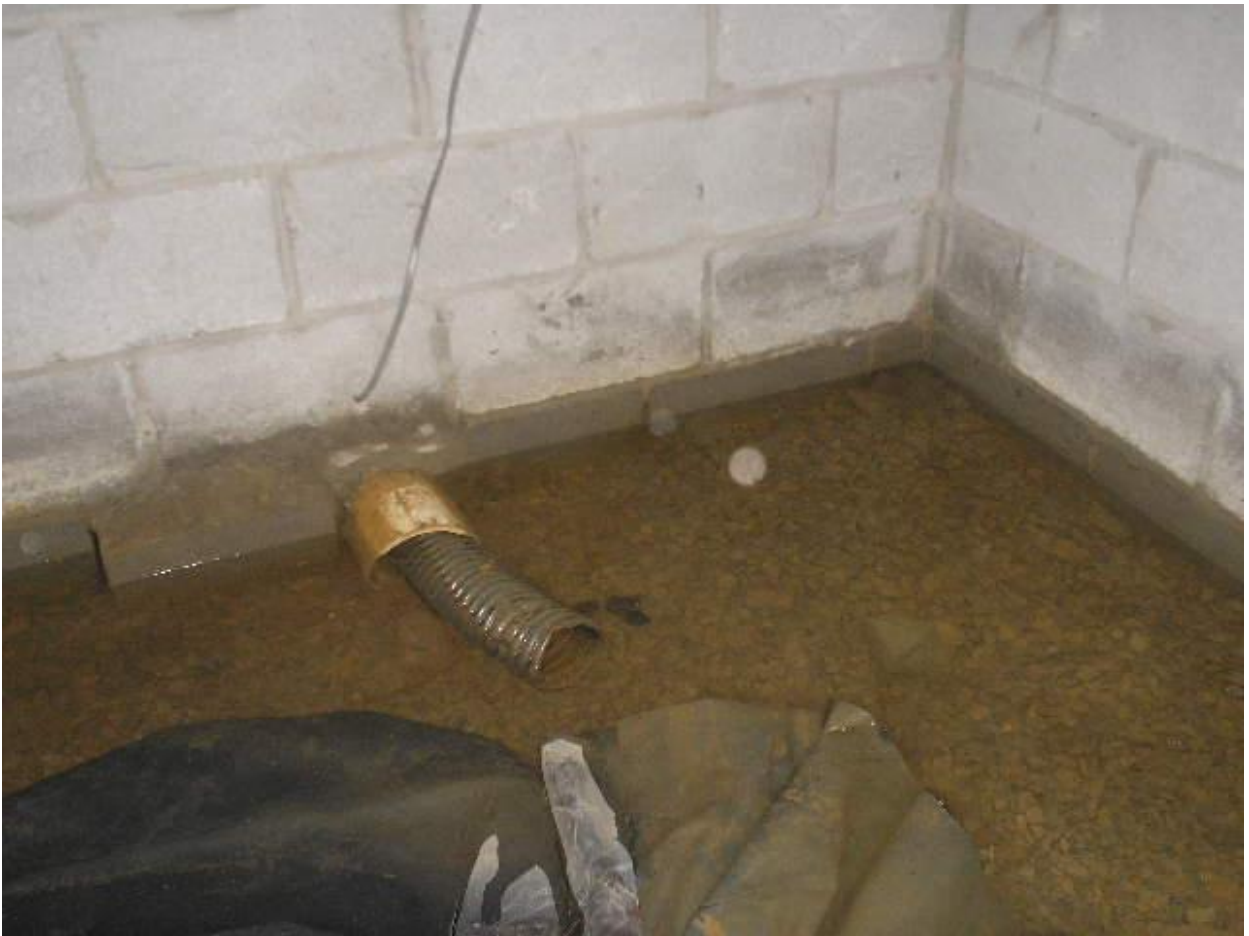
- 2.
3. Water is standing from the crawl space door up to the front left corner of the crawl, and over to the first beam under the dining/foyer.
4. This front left corner appears to be the low spot of the crawl space.
5. There is a positive drain pipe in this corner, but it is underwater and not draining out. Pipe is probably crushed/blocked underground outside.

- 6.
7. This positive drain pipe needs to be dug up outside and made to work. Extend pipe away from house.
8. This front left crawl space appears to be about 4 to 5 feet above the street level. So, there is some fall to work with here to drain the water out of the crawl space.
